Inspection Report

Property Address:
not disclosed
Sardis, BC V2R 0G4

West Coast Home Inspections

| Date: 7/22/2011 | Time: 1:00 PM | Report ID: 110722 |

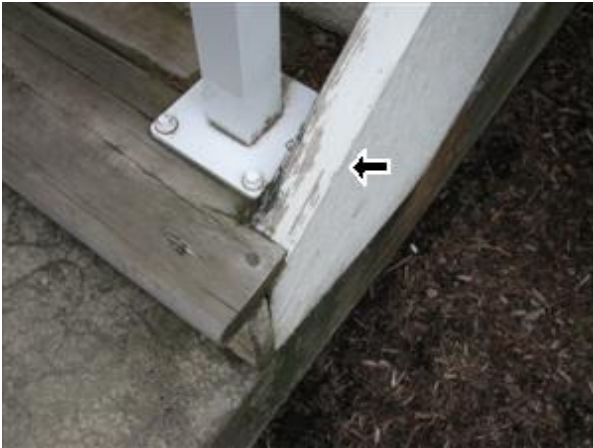
2.5 Picture 1

2.5 The front entry and enclosed decks are in satisfactory condition, relative to the age of the home. I recommend paint where required.

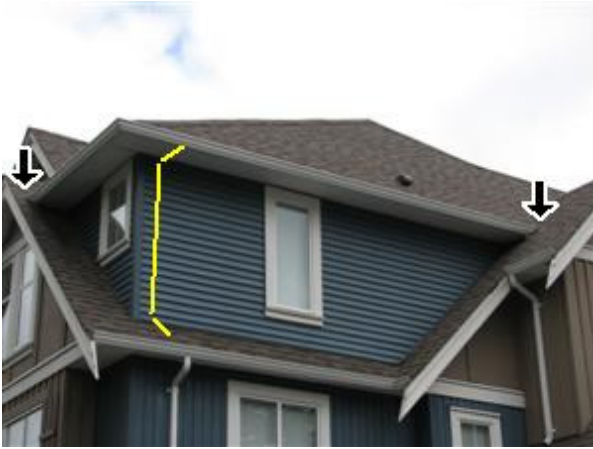
3.4 Picture 1

3.4 The gutters that are installed are fine, however there are some downspouts missing throughout the complex, with this home being one of them. It is NEVER a good idea to have all the water from a gutter evacuating out the ends against the singles of an opposing roof as this can lead to roof leaks at these locations.

A perfect example of where one home HAS the downspout, and the other is MISSING, are the matching units directly across from this one...

I recommend having the STRATA bring in the contractor who built the complex and have them finish the work they started.

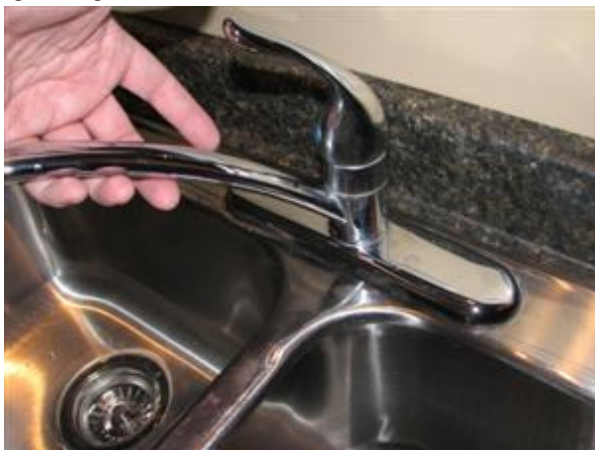
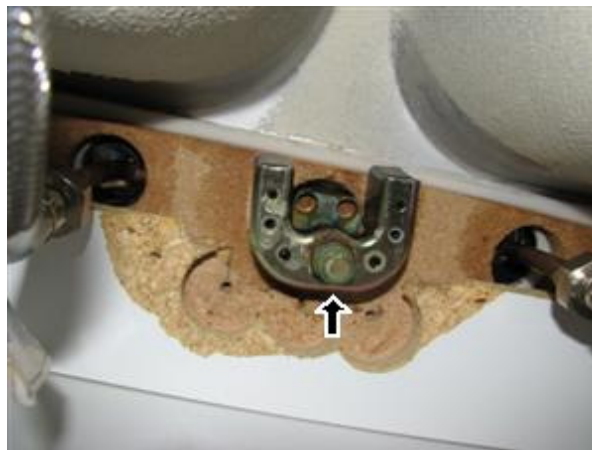
5.0 No plumbing issues noted. Fixtures worked well and drainage was satisfactory. The faucet is loose. I recommend tightening.

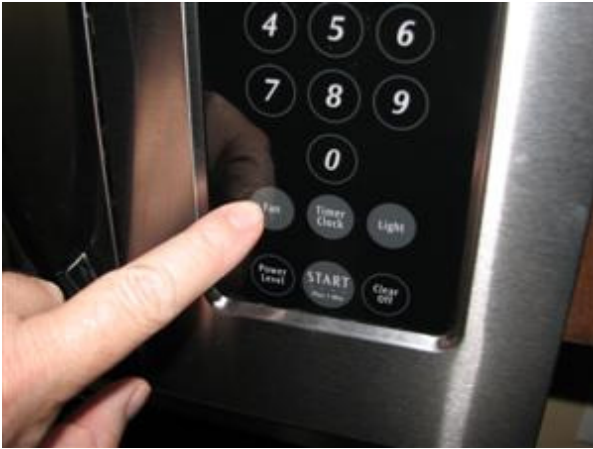
5.6 Picture 1

5.6 The FAN function on the built-in Microwave does not operate. I recommend repair or replacement.

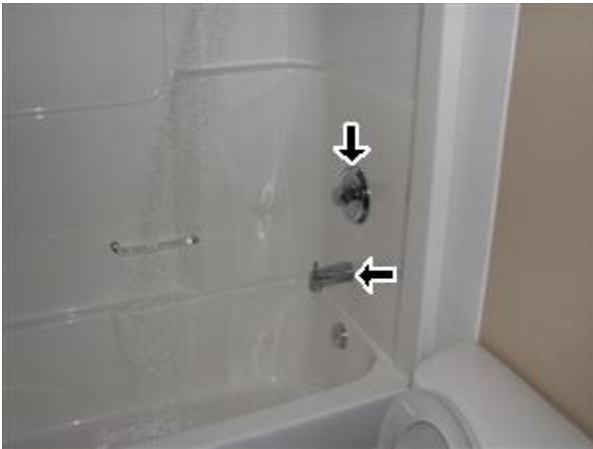
6.3 Picture 1

6.3 No issues noted with the tub faucet(s). As you want to eliminate the possibility of water being able to get in behind the wall, I recommend periodically checking the caulking around the fixtures.

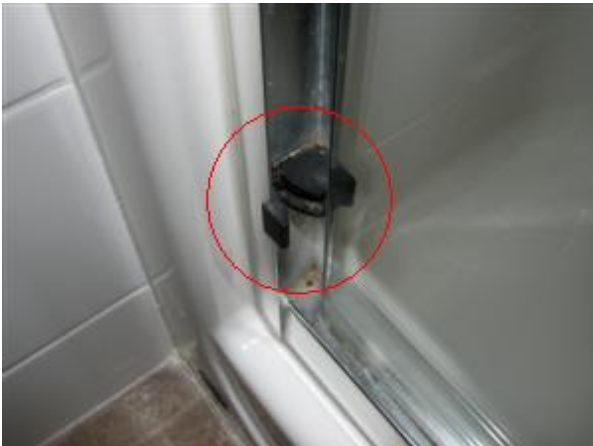
6.4 Picture 1

6.4 No issues noted with the one-piece shower stall. I ran the shower for 4 - 5 minutes and drainage was satisfactory. The FAIR rating is due to the glass door not seating properly. This leads to water splashing out onto the floor, which can cause flooring issues. I recommend this be corrected.

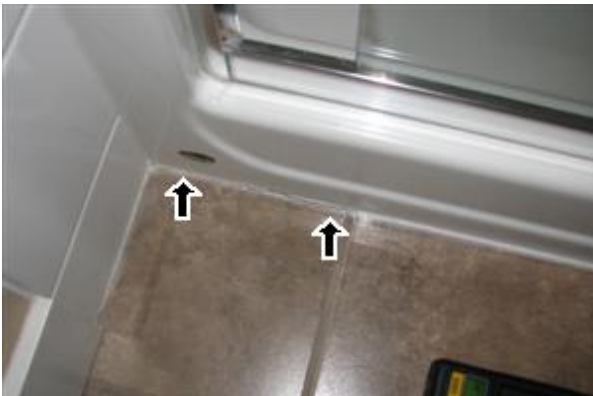
6.7 Picture 1

6.7 Flooring was tile and in satisfactory condition. I recommend periodically checking the silicone caulk along floor and tub as a regular maintenance item, as well as cleaning and sealing the grout between the tiles. No deflection noted, however absolute determination of the substrate not possible.

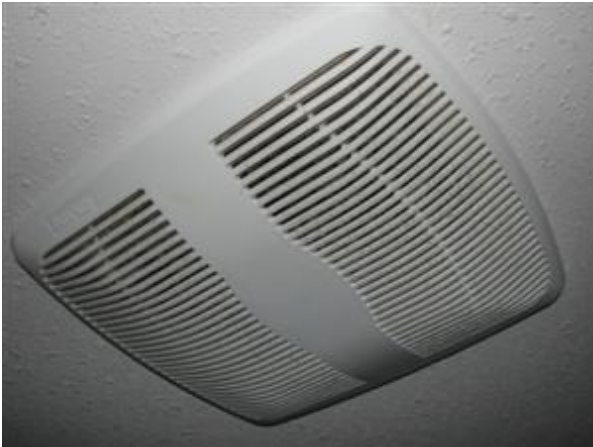
6.11 Picture 1

6.11 Ventilation was provided by a single fan and a window. I recommend cleaning the fan grill to ensure maximum efficiency and to help extend the design life of the fan motor.

As showers generate an excessive amount of humidity, which can damage ceilings and create mould & mildew growth, a recommended upgrade would be to have a licenced electrician install a **timer switch** on the ventilation fan where you will be doing the most showering, to allow 30 minutes of run-on after showering.

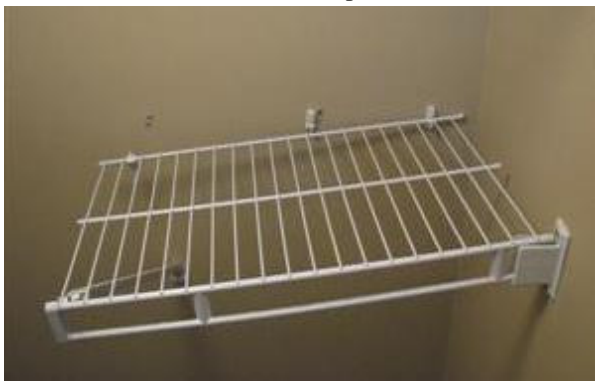
7.1 Picture 1

7.1 The walls were in satisfactory condition, typical for a home of this age. I did not see one wire shelf that has been torn from the wall. I recommend this be repaired.

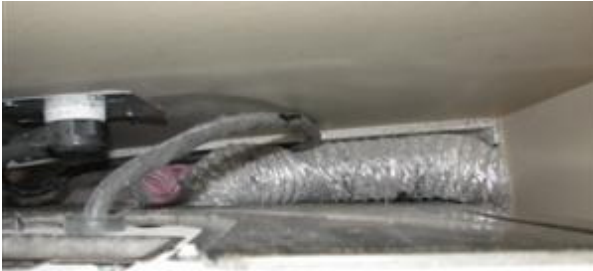
7.5 Picture 1

7.5 The dryer is vented with flexible metal ducting, which is excellent to see. I recommend periodically cleaning the duct and vacuuming any lint out from behind the dryer.

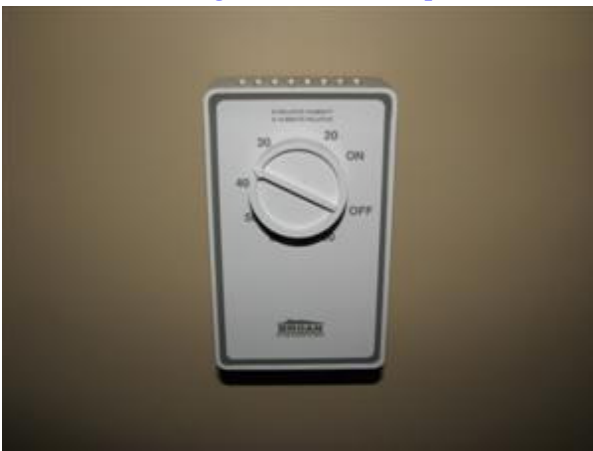
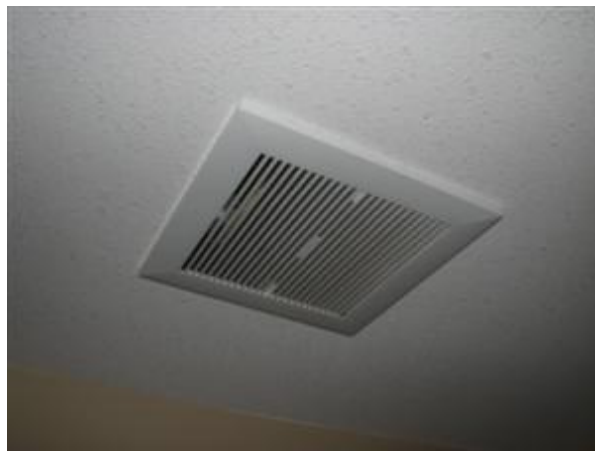
7.7 While a humidistat was noted as being installed, it was turned OFF. **It is important to always have it adjusted properly (approx 35% - 40% relative humidity) so that it does not become too humid in the home, which can lead to mould and mildew growth, which are proven health hazards.**

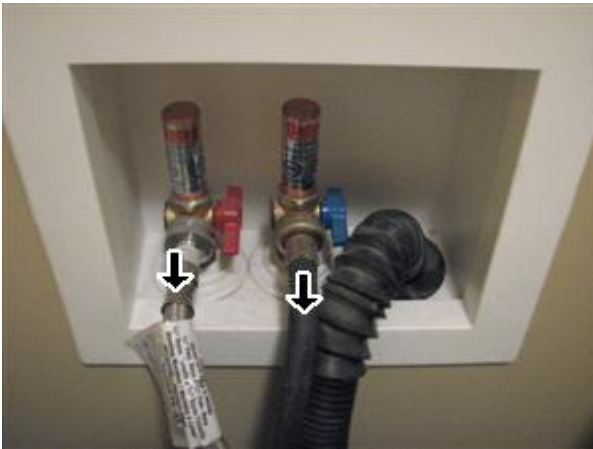
7.9 Picture 1

7.9 No issues noted with the Washer & Dryer, which were operable at the time of the inspection. I recommend periodically checking the condition of the hoses on the back of the washer as these are the most prevalent cause of in-home floods.

In this case one has been changed (the old one probably started leaking), however I would have replaced BOTH at the same time.

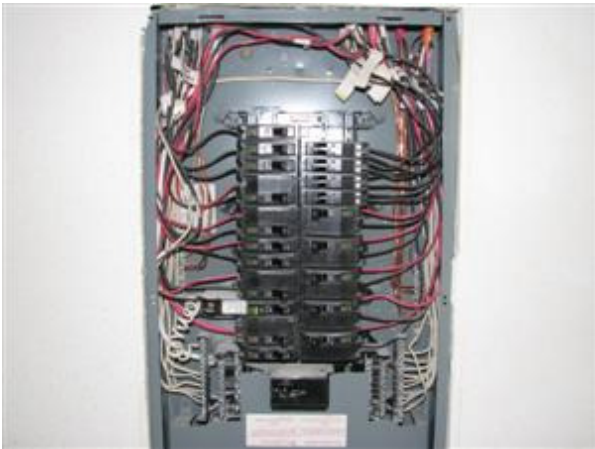
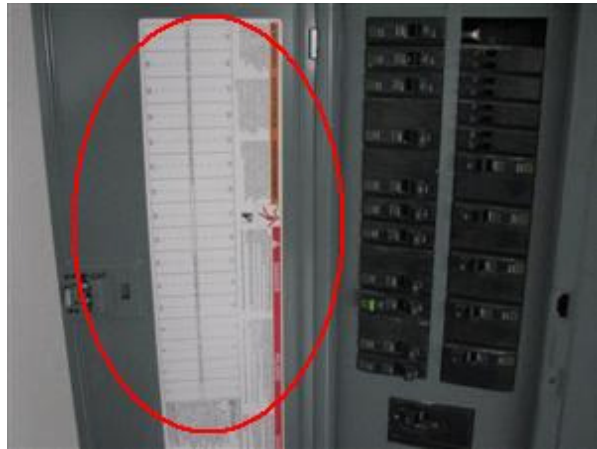
8.2 While there are no issues with the breakers and the wiring within the panel per-se... I have to say that the Electrician was a little sloppy. **NONE of the breakers have been labeled.** As a Homeowner you have no way of knowing which breaker isolates which circuit. I recommend having the Builder bring the Electrician back to complete this.

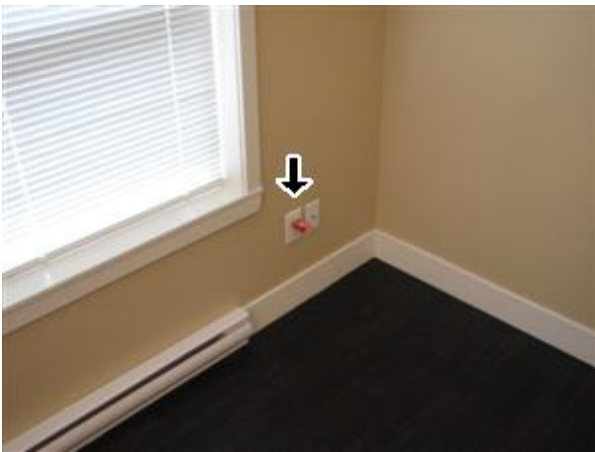
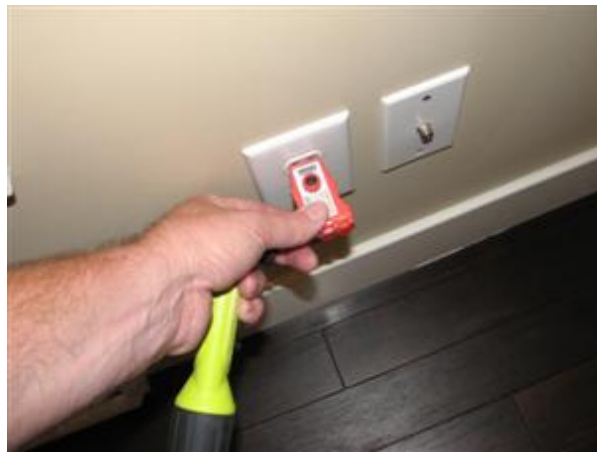
8.4 Other than one loose receptacle in the Family Room, no electrical issues noted with the receptacles, switches or fixtures at the time of inspection. I recommend the Electrician tighten the check that the connections have not become loose and tighten the receptacle.

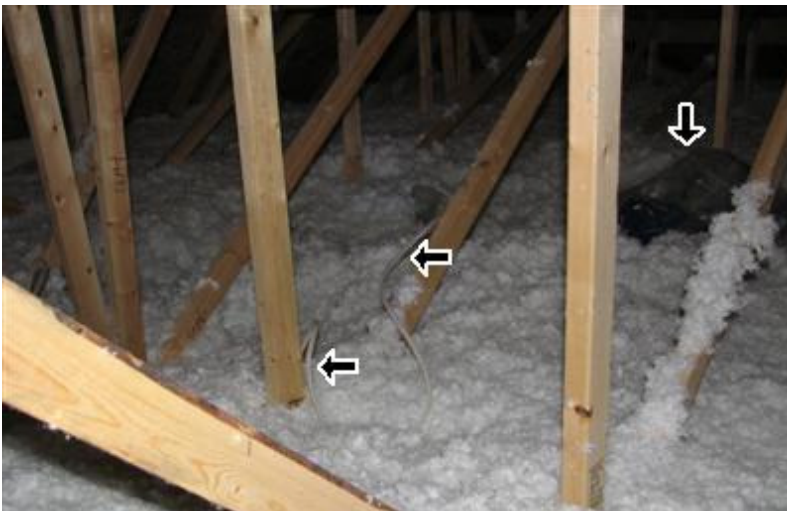
8.5 Picture 1

8.5 For the most part there are no issues noted with visible Lumex wiring. However... **up in the attic the Electrician was sloppy.** The wiring running to one of the ceiling fixtures is laying coiled loose. It should be taugt and stapled to the truss to prevent someone tripping over it. Additionally, the vapour barrier has been disturbed. I recommend the Electrician return and correct this.

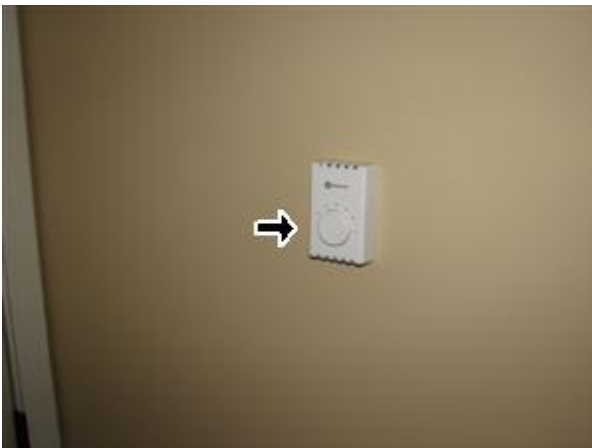
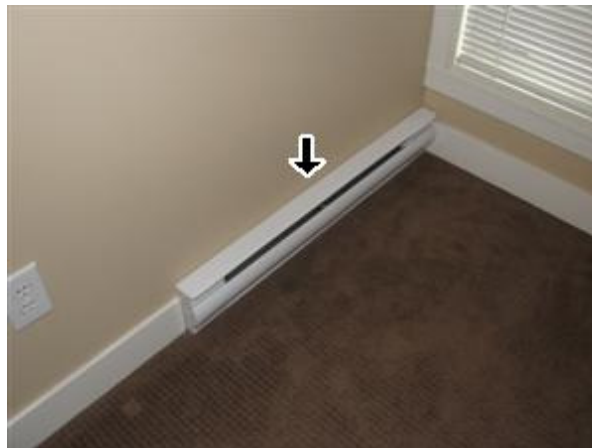
The Baseboard Heater in the upstairs, NW corner bedroom does not function. The thermostat activates when adjusted, however no heat is generated from the heater.

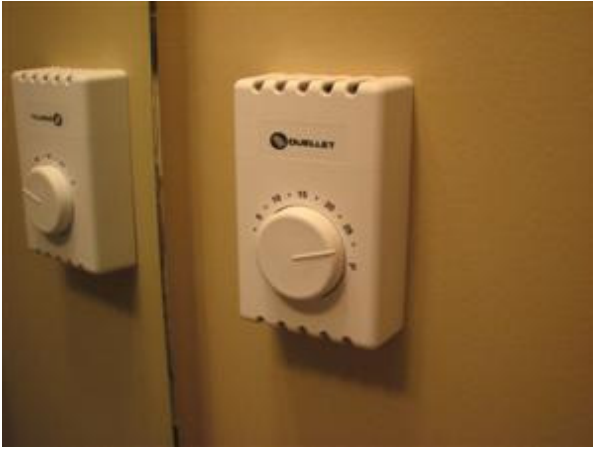
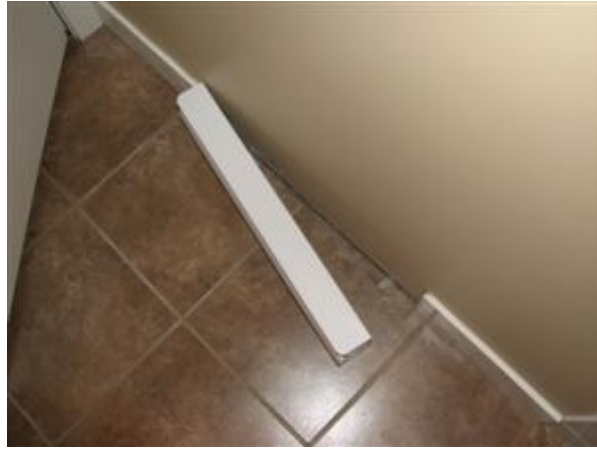
The Baseboard Heater in the Upstairs Main Bathroom does not function. Like the Bedroom, the Thermostat activates but no heat is generated. Additionally, **the Heater was never attached to the wall! I recommend The Electrician return and repair these issues!**

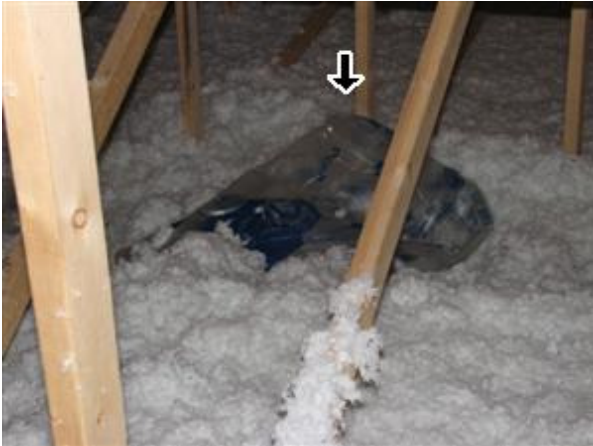
12.5 Picture 1

12.5 As previously mentioned in the Electrician Section, the Electrician needs to return to repair the mess he made of the Vapour Barrier.
