Inspection Report

Property Address:
Not Disclosed
Coquitlam, BC

West Coast Home Inspections Ltd.

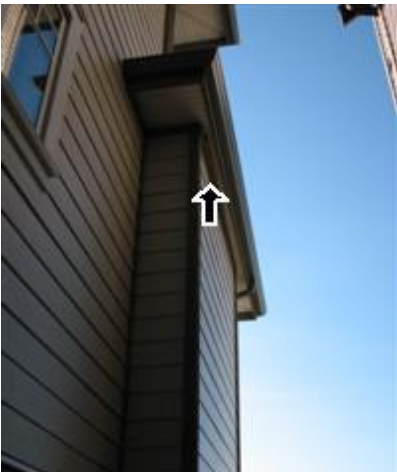
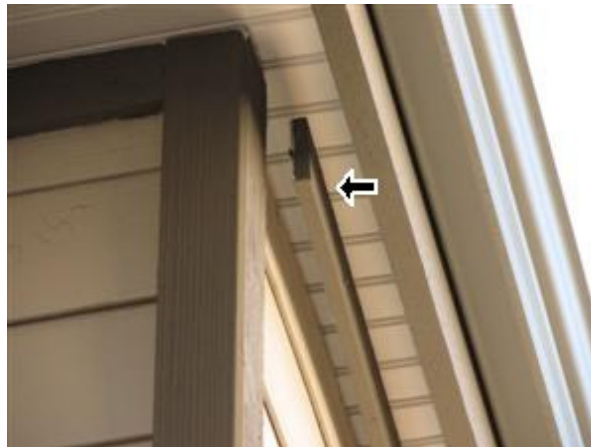
2.0 The 1x4 trim on the West side of the home has come loose and is going to fall off. The builder tried to nail it at an angle, which is not going to penetrate hardy board (your siding). I recommend repairs before it falls completely. Also... I recommend sealing around any penetration points and openings with clear silicone, and installing flashing where required. This exposed area is vulnerable and water will get in behind the rock fascia unless repairs are made.

The 1x4 trim on the West side of the home has come loose and is going to fall off. The builder tried to nail it at an angle, which is not going to penetrate hardy board (your siding). I recommend repairs before it falls completely.

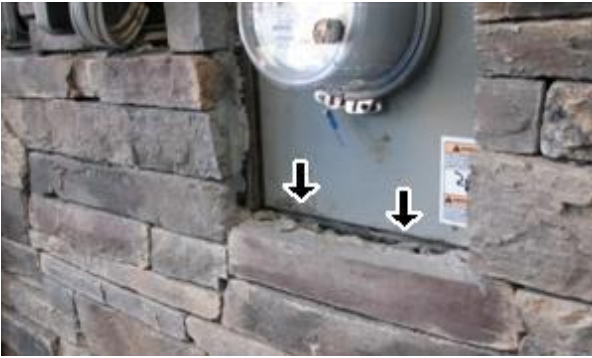
2.0 Picture 3

installing flashing where required. This exposed area is vulnerable and water will get in behind the rock fascia unless repairs are made.

Also... I recommend sealing around any penetration points and openings with clear silicone, and

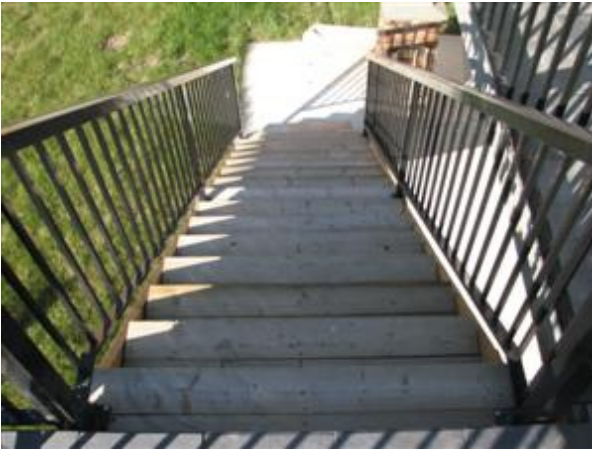
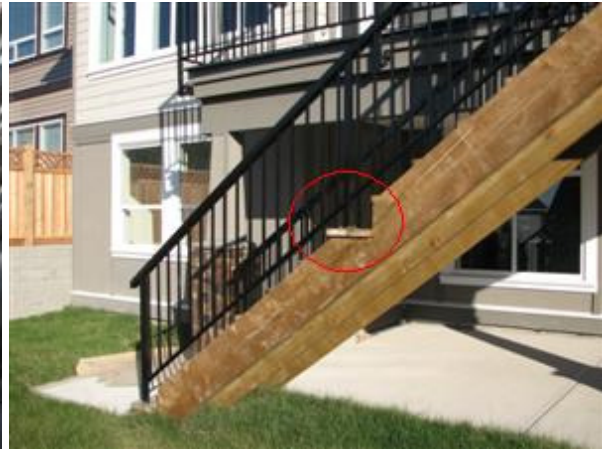
As the deck is higher off the ground that standard, the stairs at the back of the home are very long. They have also been "notched" mid-way to allow for the installation of the handrail, which effectively weakens the stair at the point where it needs to be the strongest.

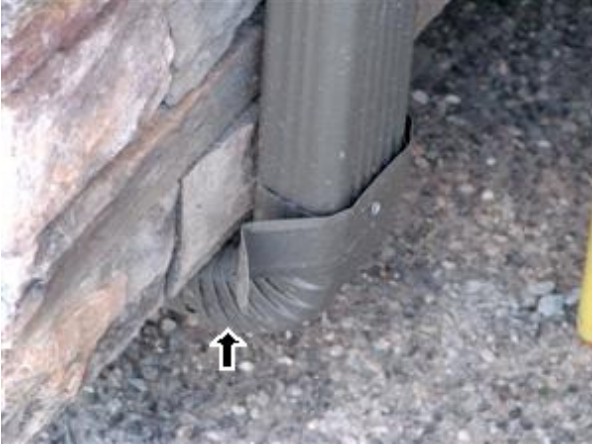
3.4 Picture 1

3.4 Overall the gutters and downspouts are in satisfactory condition, however the lower strap, meant to secure the downspout in place, has not been fastened. I recommend this be addressed.

Overall the gutters and downspouts are in satisfactory condition, however the lower strap, meant to secure the downspout in place, has not been fastened. I recommend this be addressed.

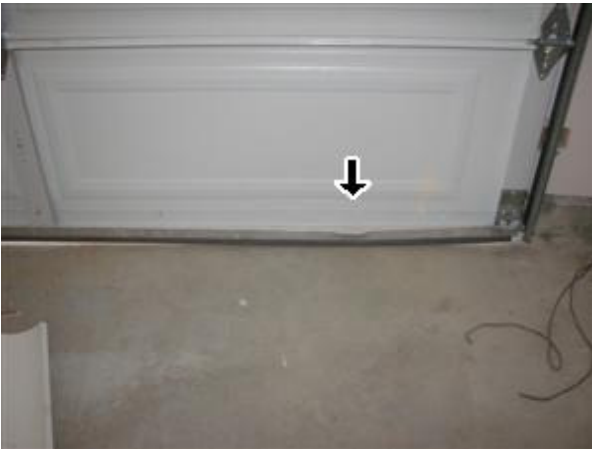
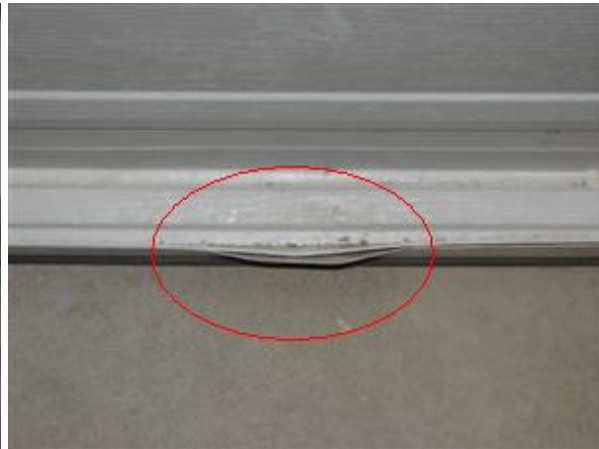
4.3 The garage door is dented in the lower right corner (as viewed from inside). It is not visible from the outside however, as the home is brand new (and should be in perfect condition when delivered to you), I recommend you have the contractor repair this.

The garage door is dented in the lower right corner (as viewed from inside). It is not visible from the outside however, as the home is brand new (and should be in perfect condition when delivered to you), I recommend you have the contractor repair this.

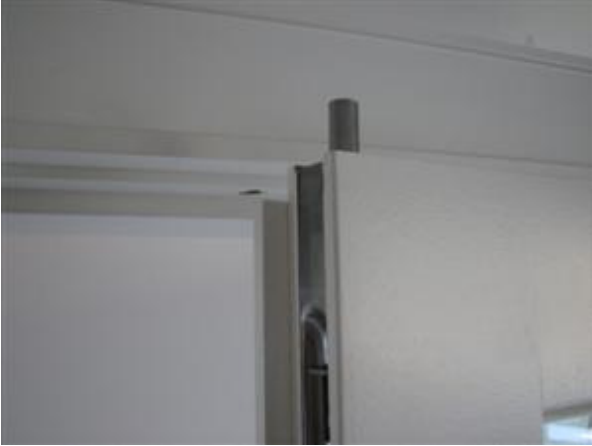
5.3 Picture 1

1. The French Doors into the Den not secure because the strike does not line up with the hole that was drilled in the frame. I recommend repairs by a qualified contractor.

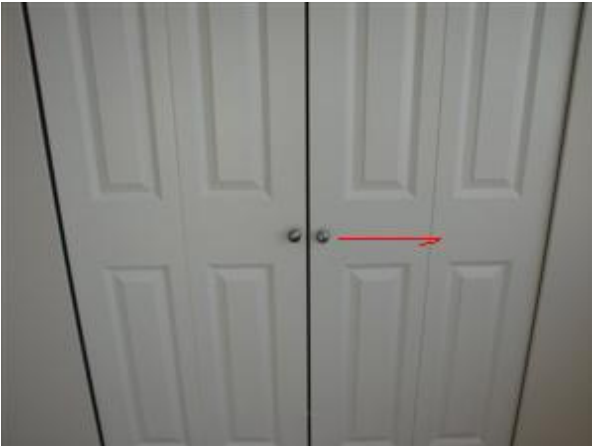
5.3 Picture 2

2. The closet door knobs were installed in the wrong location in the downstairs bedroom. I recommend replacing the doors as any repair attempts will be visible.

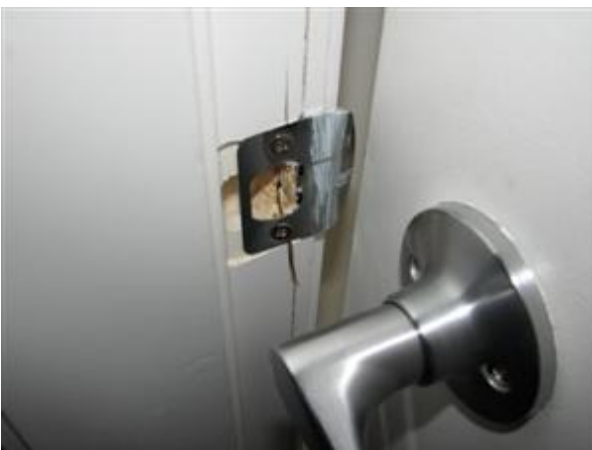
5.3 Picture 3

3. The strike and plate in the door into the basement suite are not correct, and damage has already occurred. I recommend the entire door frame be replaced and the correct passage set & strike be installed.

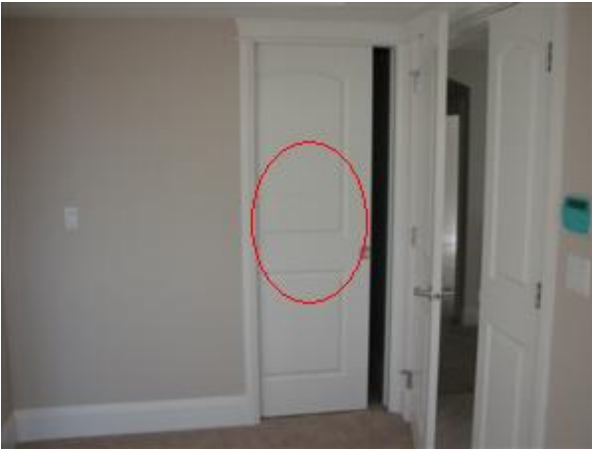
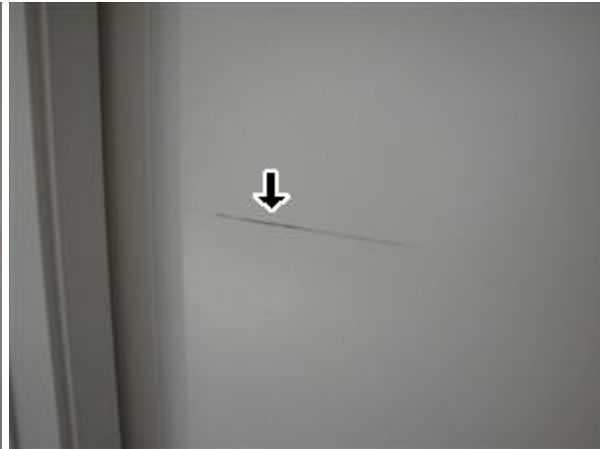
4. The Finisher used nails that were too long to secure the moulding. The nails have scraped against the side of the pocket door. I recommend repairs by a qualified contractor.

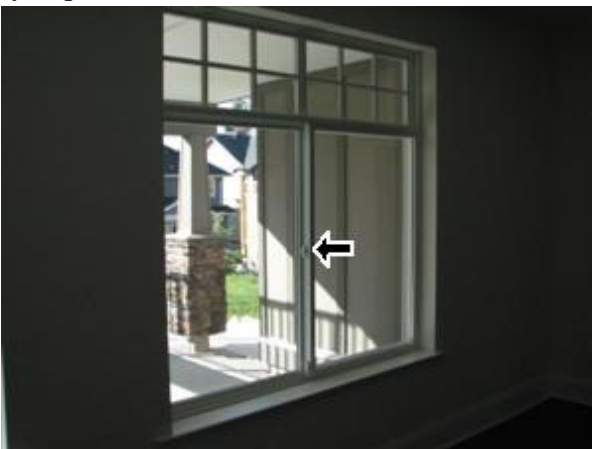
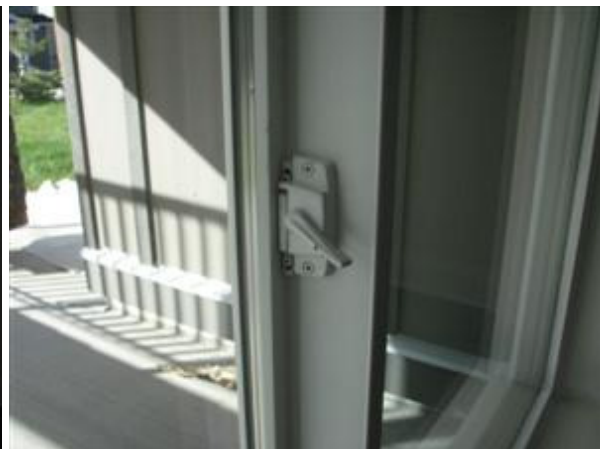
5.4 The living room window in the basement suite does not latch. This may be correctable with an adjustment, or it may be a poorly manufactured window that does not align. I recommend repairs by a qualified contractor.

The living room window in the basement suite does not latch. This may be correctable with an adjustment, or it may be a poorly manufactured window that does not align. I recommend repairs by a qualified contractor.

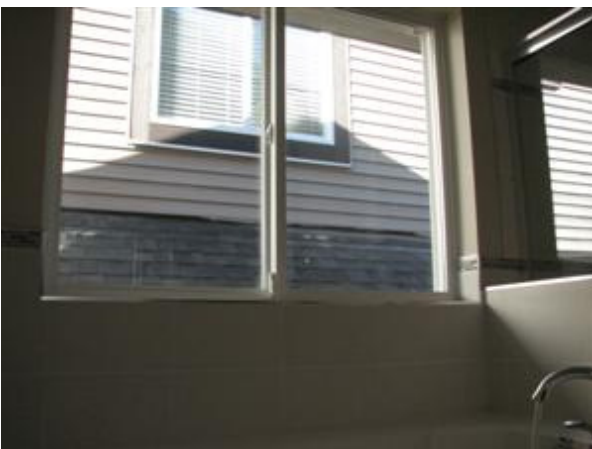
5.4 Picture 3

While aesthetics aren't my concern, wouldn't you prefer privacy glass beside the soaker tub in the Master Ensuite?

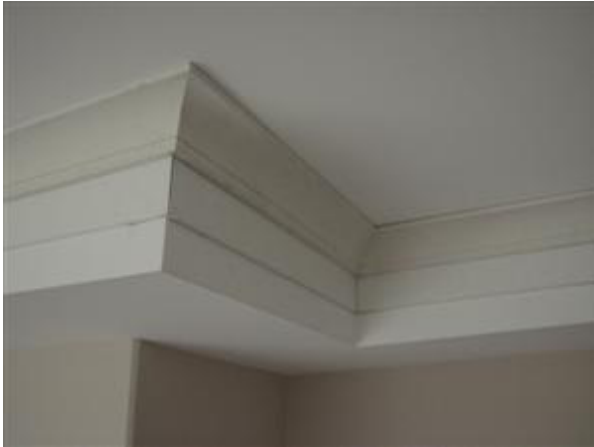
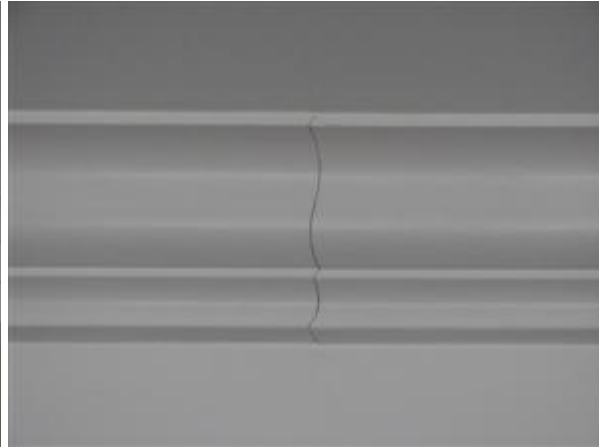
It is possible that the contractor plans on returning to finish the trim, but just in case... finishing is required in the Master Bedroom, as well.... separation is occurring over the arch in the Main Floor Living Room.

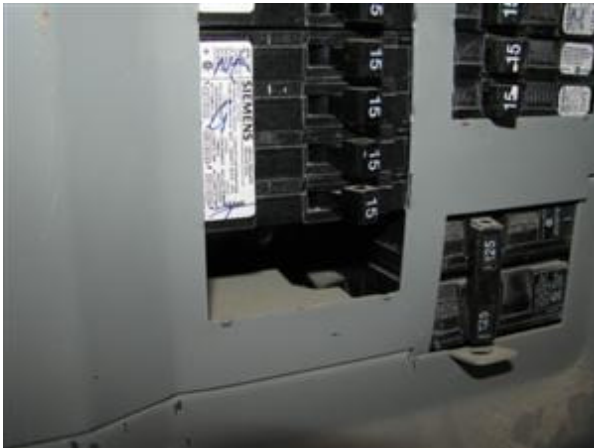
6.2 Picture 1

6.2 The front panel cover is either missing a couple breakers (labeled Lights & Plugs), or there needs to be "knock-out plugs" installed to prevent anyone from sticking their fingers into the panel. I recommend a qualified Electrician plug these.

The front panel cover is either missing a couple breakers (labeled Lights & Plugs), or there needs to be "knock-out plugs" installed to prevent anyone from sticking their fingers into the panel. I recommend a qualified Electrician plug these.

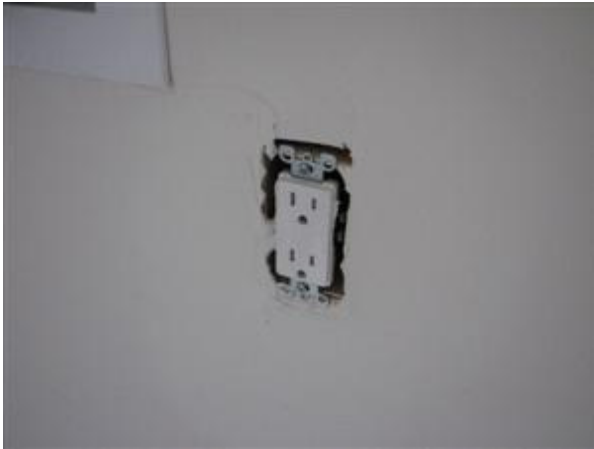
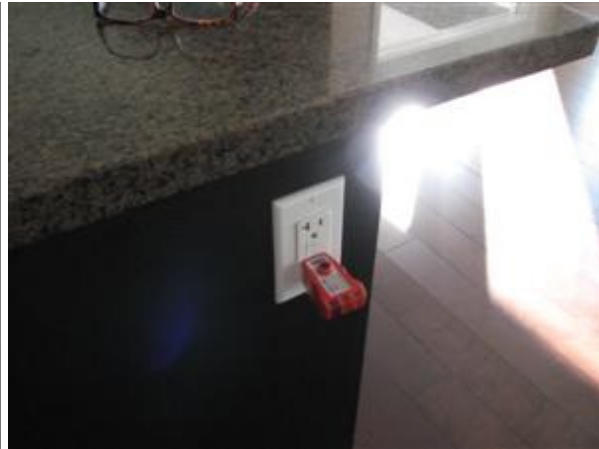
6.4 There is one missing cover plate in the basement suite laundry that needs to be repaired for obvious safety reasons. There is also one non-functioning GFCI receptacle in the upstairs kitchen island, which requires replacement by a qualified contractor.

There is one missing cover plate in the basement suite laundry that needs to be repaired for obvious safety reasons. There is also one non-functioning GFCI receptacle in the upstairs kitchen island, which requires replacement by a qualified contractor.

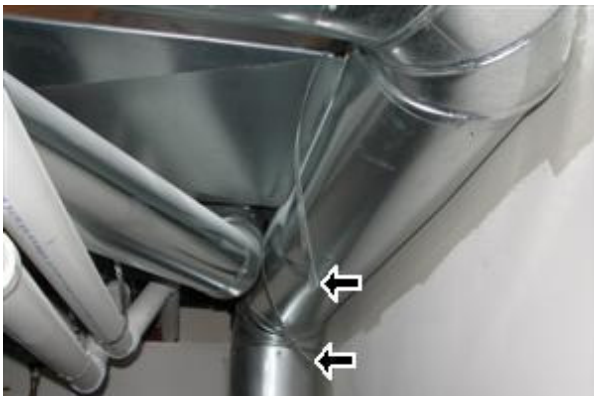
9.7 Picture 1

9.7 There is dangling support strapping at the main heating trunk. It looks like two straps were INTENDED for installation, but they were two short so the contractor just left them. This is a heavy duct and requires support. I recommend longer straps be installed as originally planned.

There is dangling support strapping at the main heating trunk. It looks like two straps were INTENDED for installation, but they were two short so the contractor just left them. This is a heavy duct and requires support. I recommend longer straps be installed as originally planned.

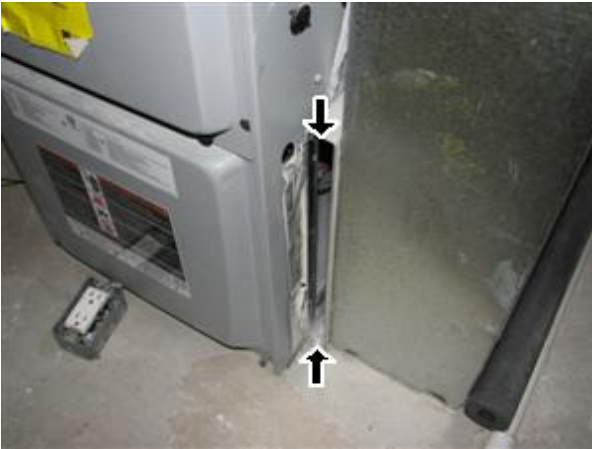
9.8 Picture 1

9.8 The filter is missing. It is likely one has never been installed. I recommend installing a filter ASAP and having the contractor bring in an HVAC Tech to professionally clean the furnace, which has accumulated an excessive amount of dust during the construction phase.

The filter is missing. It is likely one has never been installed. I recommend installing a filter ASAP and having the contractor bring in an HVAC Tech to professionally clean the furnace, which has accumulated an excessive amount of dust during the construction phase.

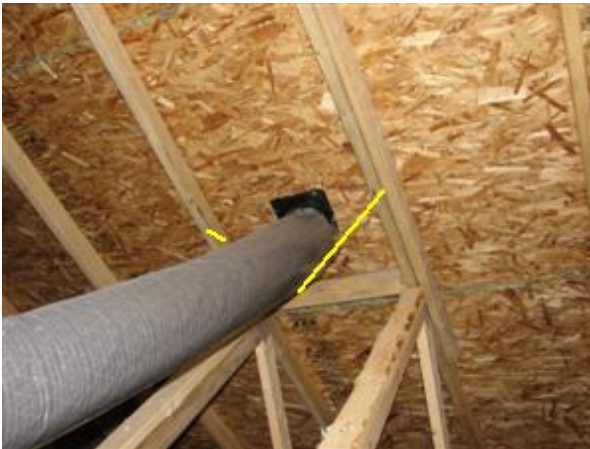
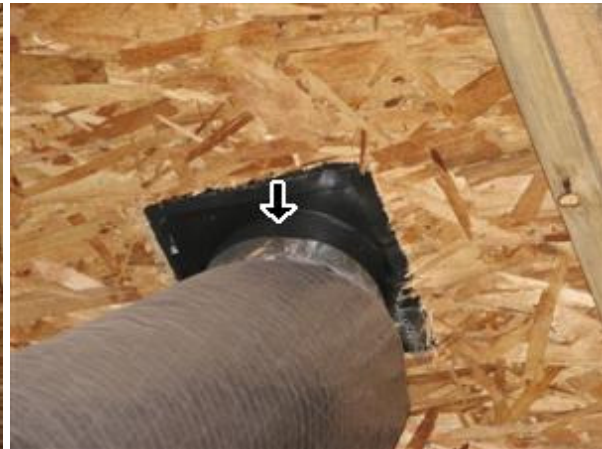
The exhaust venting in the attic is not secured. I recommend having your contractor go up into the attic and use flexible metal straps to secure & support the longer sections of insulated exhaust venting to the trusses. At present they are held on with tape, which will come loose under the stress of the weight of the vent itself. When this happens the vent will fall all the humidity from your bathroom will go directly into your attic, which can lead to mould issues.

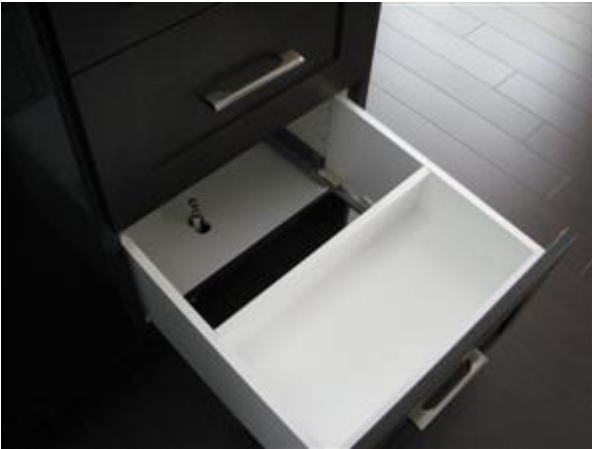
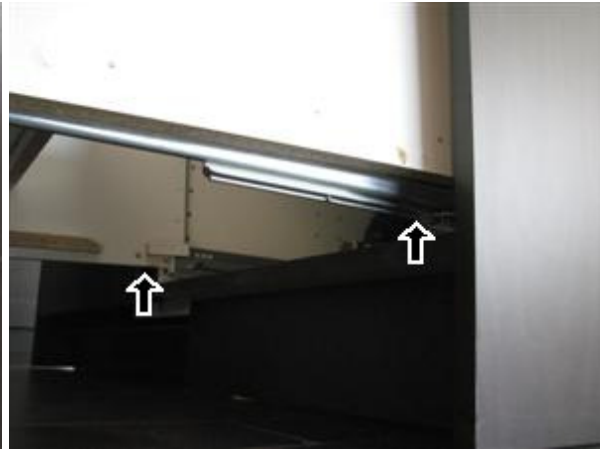
The drawer in the island in the basement suite has been modified in an attempt to accommodate the plumbing for the Dish Washer. The modifications have compromised the drawer (which will fall apart if you attempt to use it). I recommend having the cabinet company repair as necessary.

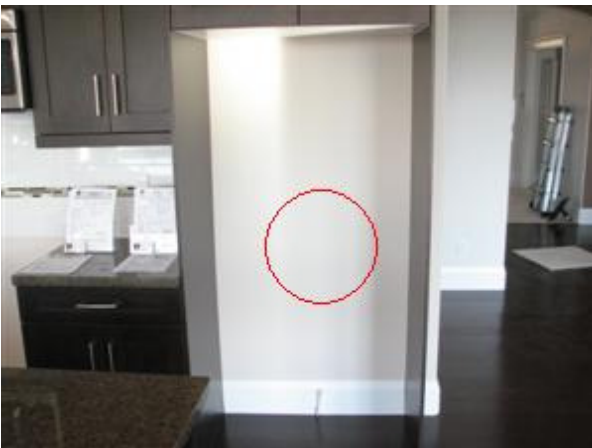
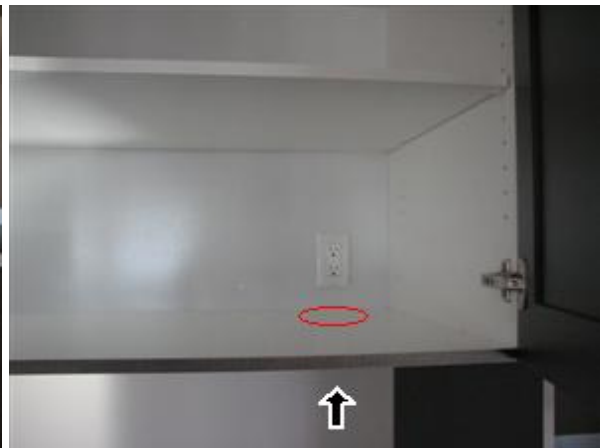
While the refrigerator has not yet been installed, I would like to point out that THERE IS NO ELECTRICAL OUTLET in the wall behind the refrigerator.

For whatever reason, the electrician placed the receptacle far too high on the wall, and nobody picked up on this before the cabinets were installed. Short of removing the cabinet and having the Electrician relocate the receptacle, then having a drywaller come back to repair the wall damage, and then have the cabinet installers return to re-hang the cabinet (which would be the ideal way to correct this)... you will have to have a 2" hole bored into the bottom of the cabinet.
