Inspection Report

Property Address:
not disclosed
Surrey, BC V4N 5S8

Date: 8/31/2011	Time: 10:00 AM	Report ID: 110831
Property: not disclosed Surrey, BC V4N 5S8	Customer: Client not disclosed	Real Estate Professional:

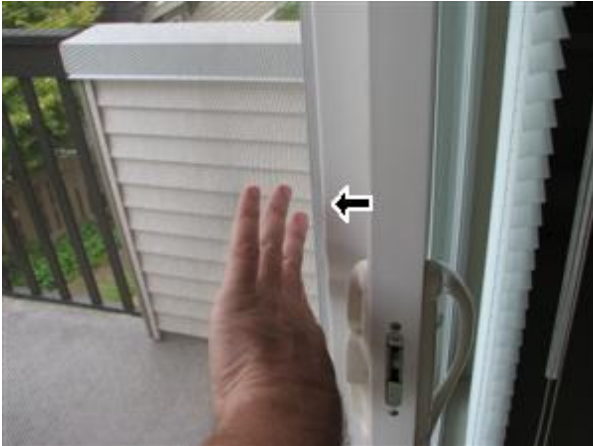
2.4 Picture 1

2.4 The screens are in satisfactory condition, relative to the age of the home. Note that the rear sliding door screen is slightly bowed and catches on the frame when closing.

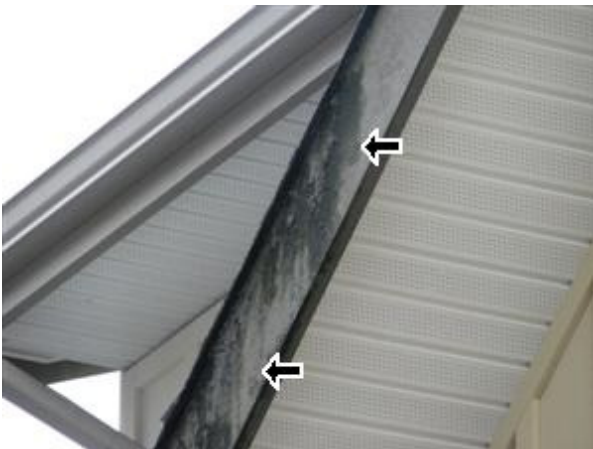
2.7 Picture 1

2.7 The fascia and soffits and eaves were in satisfactory condition. I recommend periodically repainting and caulking the seams as a necessary form of maintenance. Due to some flashing damage, the fascia along the North side requires cleaning and painting. I recommend advising the STRATA.

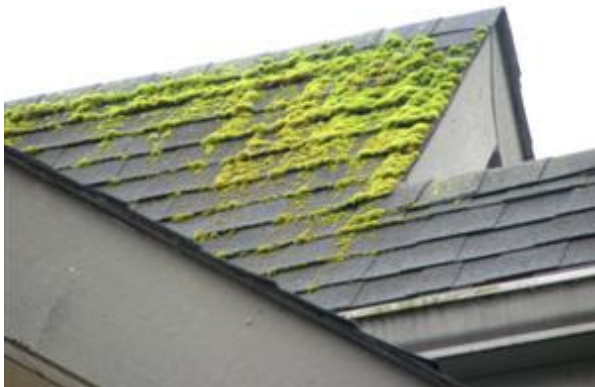
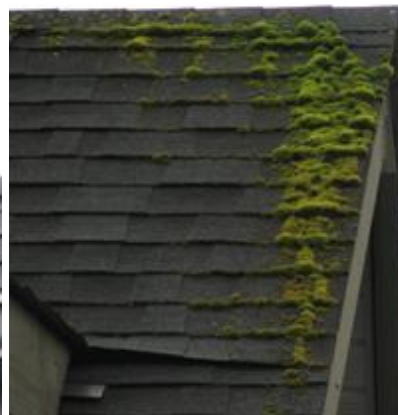
3.0 The asphalt shingled roof is in Satisfactory condition, with many years of life remaining. Fairly heavy Moss growth was noted on the North side. I recommend applying a killing agent to stop the growth, as the moss can get under and lift the shingles, causing damage and pre-mature failure.

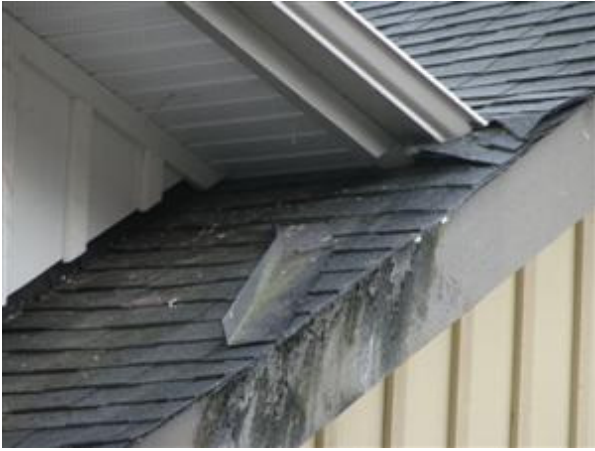
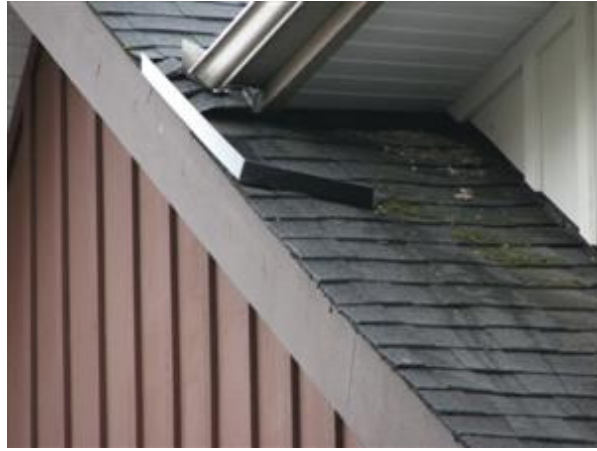
3.1 The flashing has come loose along the North side and as a result, the fascia is getting weather-worn at an advanced rate. I recommend advising STRATA that this needs to be repaired by a qualified Roofer.

The picture on the LEFT shows how it currently is, while the picture on the RIGHT shows how it should be.

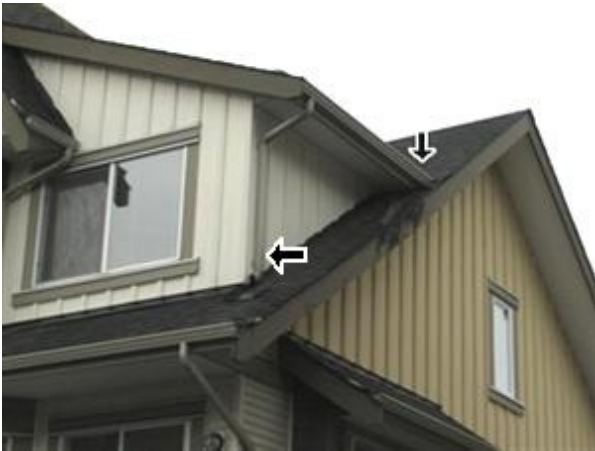
3.1 Picture 3

Ideally, I would prefer to see the open end of the gutter closed off completely so that the downspout can take the water to the lower level. This would eliminate the need for the flashing altogether, and prolong the life of the roof surface at the water spill-point. You can also mention this to your STRATA as a recommended suggestion.

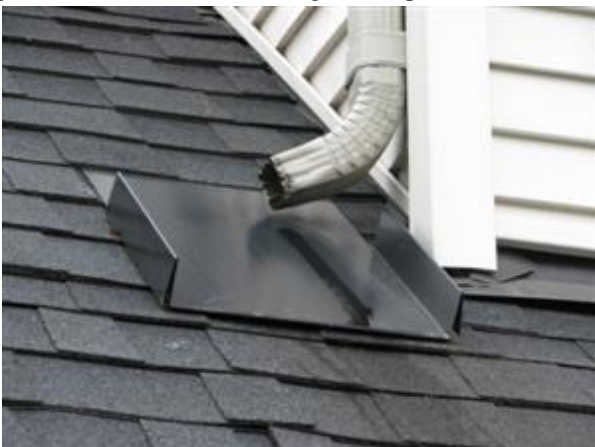
3.4 Picture 1

3.4 The gutters and downspouts are in satisfactory condition. While the contractor placed flashing under the downspouts to protect the surface of the shingle from premature wear...

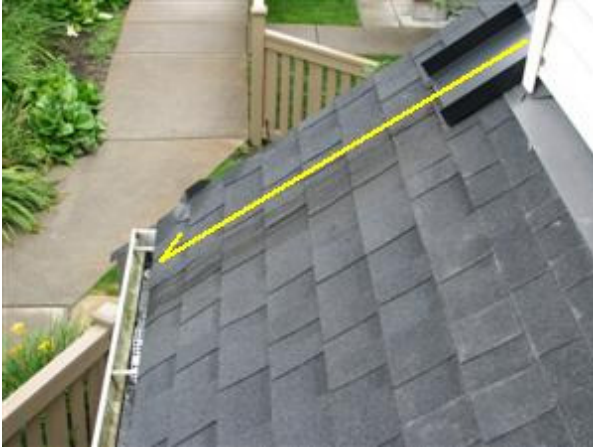
3.4 Picture 2

...I still prefer to see the downspouts extending right to the lower gutter. Even with the protective flashing, staining of the shingle surface is evident after 5 years.

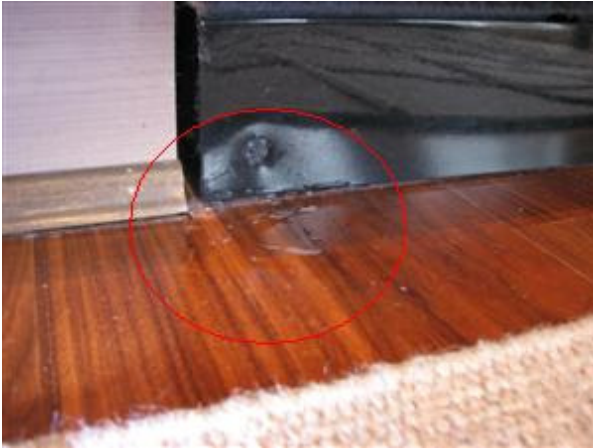
5.8 Picture 1

The reason for the FAIR rating is that there is a slight leak from the Dishwasher while in operation. It may be originating from the door seal, or it could be coming from underneath. Further evaluation required to determine, however I recommend the cause be determined and repaired before your flooring is damaged.

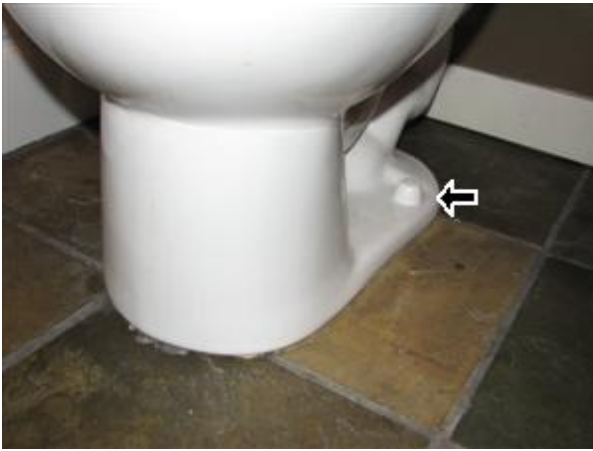
6.1 Picture 1

6.1 The toilet mounts are slightly loose at the floor in the Main Bathroom. Moisture testing detected **no** elevated moisture-content levels in the substrate, however the implications of a loose toilet are leaks, particularly at the wax seal and at the supply piping connection, which can cause significant damage to the floor underneath the covering. Repairs may involve se-setting the toilet on a new wax ring (and possible substrate repair). I recommend a qualified licenced plumber repair as required.

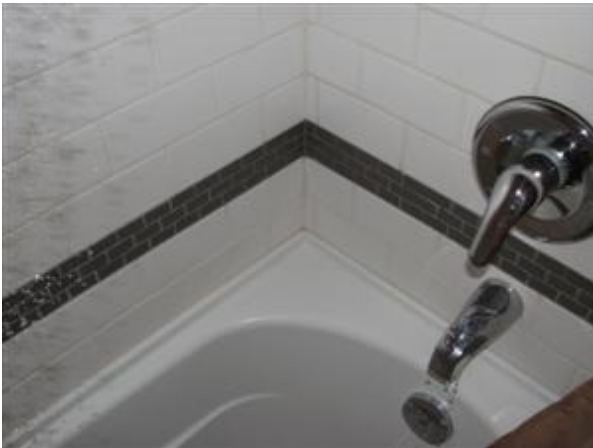
6.2 Picture 1

6.2 The tub has a tiled backsplash. While currently in satisfactory condition, as tiles will leak over time **if left unattended**, I recommend that the entire enclosure be periodically checked, cleaned and sealed as necessary, as part of a regular maintenance item.

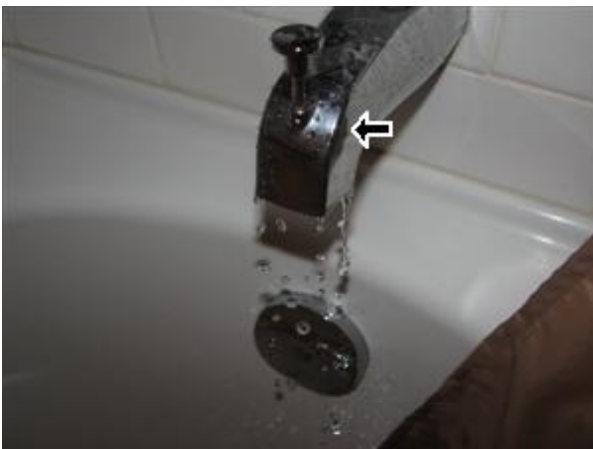
6.3 Picture 1

6.3 Other than a slight diverter leak (water still comes out faucet when shower is activated), no issues noted with the tub faucet(s). As you want to eliminate the possibility of water being able to get in behind the wall, I recommend periodically checking the caulking around the fixtures.

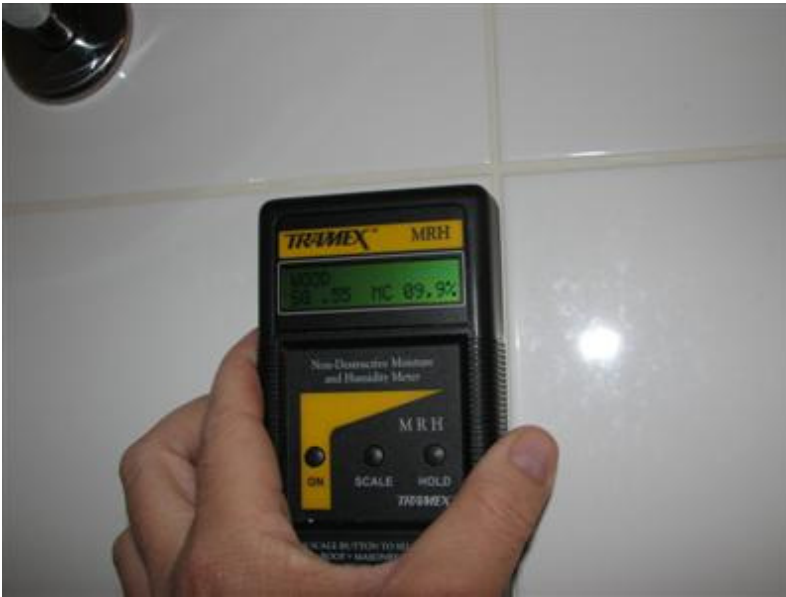
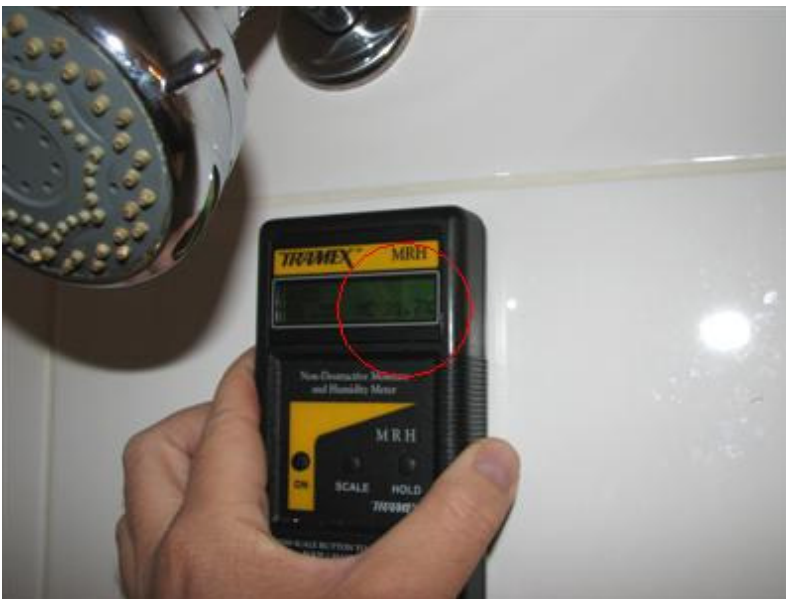
6.4 There are no issues with the Shower Stall in the Ensuite Bathroom per se, however, upon opening the shower door I noted a distinct MUSTY smell. Moisture testing revealed that that the wall is damp directly underneath the shower head (Pictures 1 & 2... note how much my moisture meter jumps in Picture 2, when moved over just 6").

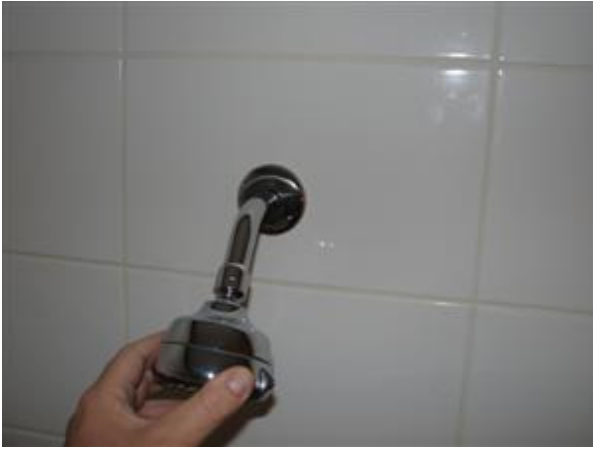
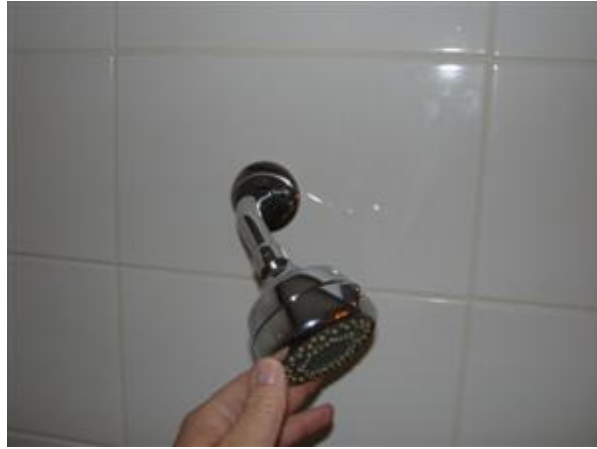
Water is leaking behind the wall due to a loose shower head... I can not determine how much water has leaked, and for how long - nor can I make an evaluation on how much mould may or may not be behind the wall, however the musty smell could be an indication that some is present. I recommend further evaluation and repairs by a qualified Plumber.

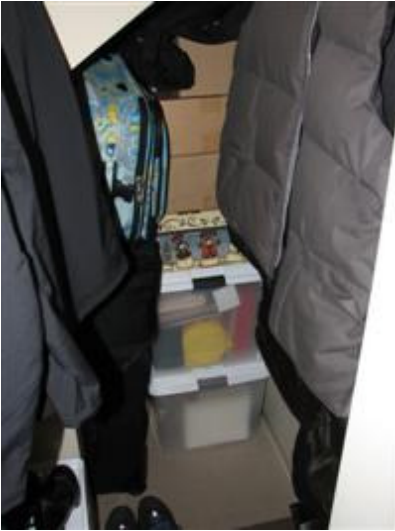
7.7 Picture 1

7.7 Closets and storage areas that are over-full (especially if there are cabinets in them) are inaccessible to me, as such I am unable to conclusively determine the condition of the floors or walls behind them.

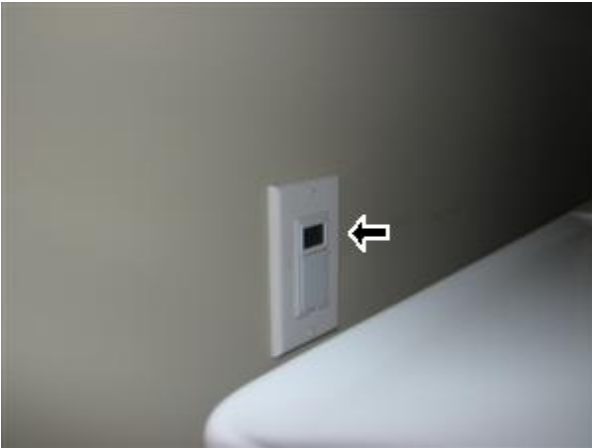
7.8 Picture 1

7.8 There is no actual "humidistat" in the home, per se... however there is a timer switch in the Laundry Closet, that activates the Main bath fan. I recommend setting this so that it cycles on and off at 4 hour intervals.

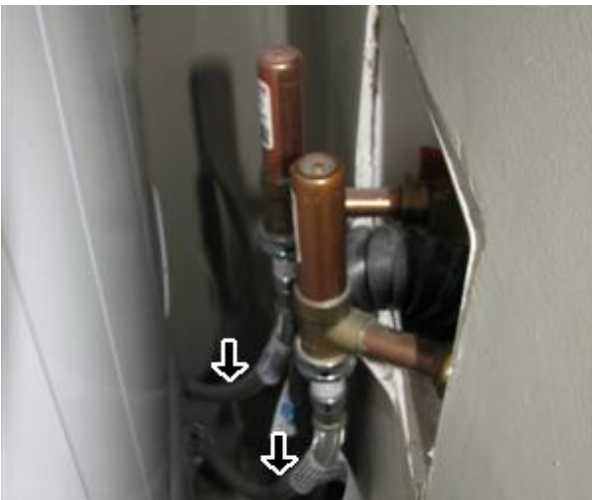
7.10 Picture 1

7.10 No issues noted with the Washer & Dryer, which were operable at the time of the inspection. I recommend periodically checking the condition of the hoses on the back of the washer as these are the most prevalent cause of in-home floods.

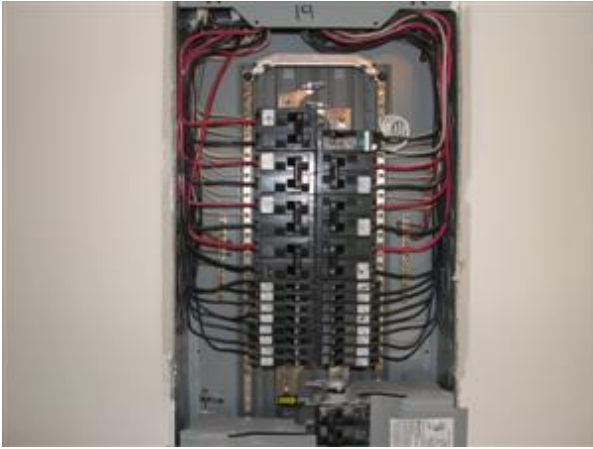
8.2 Picture 1

- 8.0** Underground service not visible. No issues noted.
- 8.1** Ground wire located; no issues noted with grounding when testing electrical receptacles.
- 8.2** The distribution panel was professionally installed, more than capable of handling the electrical load, with no issues noted.

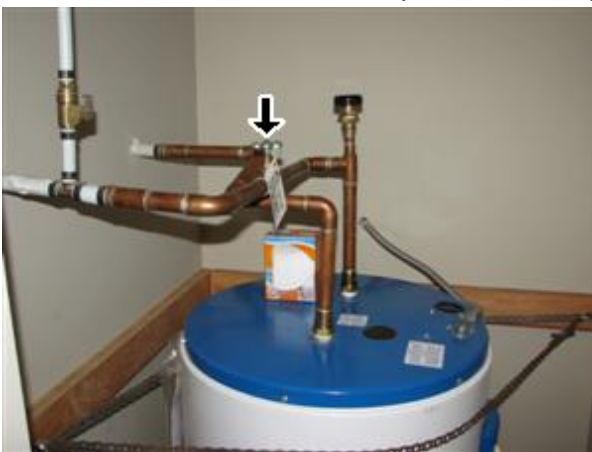
10.1 Picture 1

10.1 HW Tank shut-off located directly above the tank (pictured).

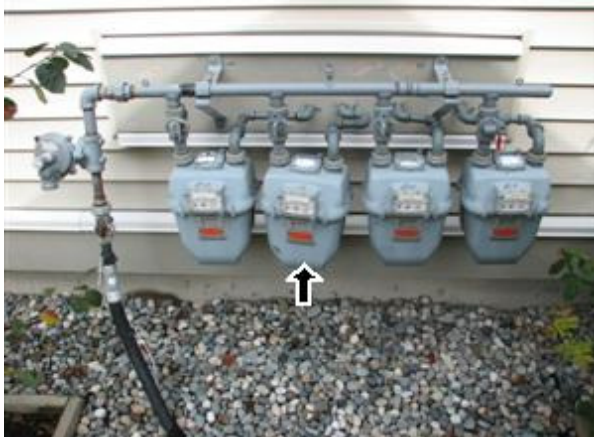
11.3 Picture 1

11.3 The Main Gas shutoff is located at the exterior of the building. This is something that, as a homeowner, you would generally not touch.

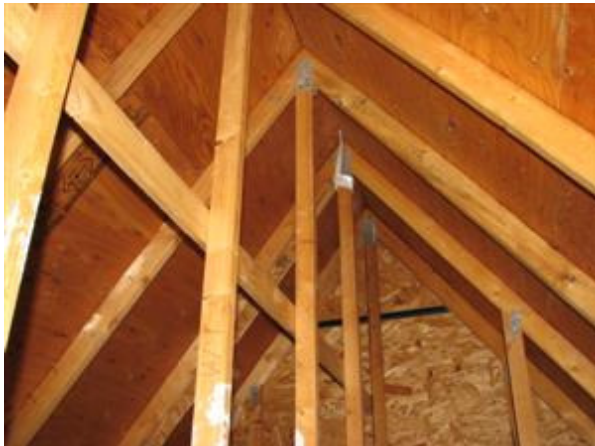
12.0 Picture 1

12.0 No issues or modifications noted with the engineered trusses.

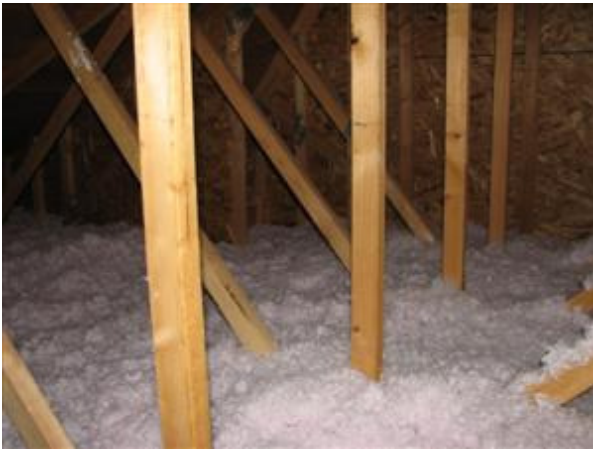
12.3 Picture 1

12.3 Insulation was 10" - 12" of blown fiberglass. No issues noted.

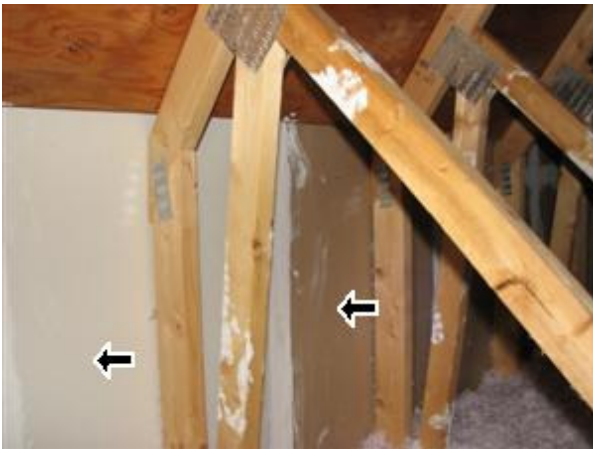
12.7 Picture 1

12.7 Firestop in place. No issues noted.
