# Inspection Report

**Property Address:**  
Not Disclosed  
North Vancouver, BC V7M 1H6

**West Coast Home Inspections**

<b>Date:</b> 2/23/2012	<b>Time:</b> 11:00 AM	<b>Report ID:</b> 120223
<b>Property:</b> Not Disclosed North Vancouver, BC V7M 1H6	<b>Customer:</b> Client Not Disclosed	<b>Real Estate Professional:</b> Undisclosed

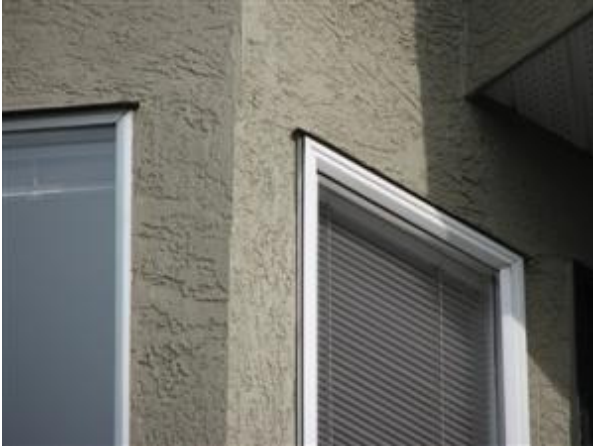
2.3 Picture 1

**2.3** As viewed from the exterior, the windows are in satisfactory condition, consistent with the age of the home. As a preventative maintenance measure I recommend the STRATA periodically apply silicone caulking where the window trim

and siding meet, to minimize moisture and insect penetration.

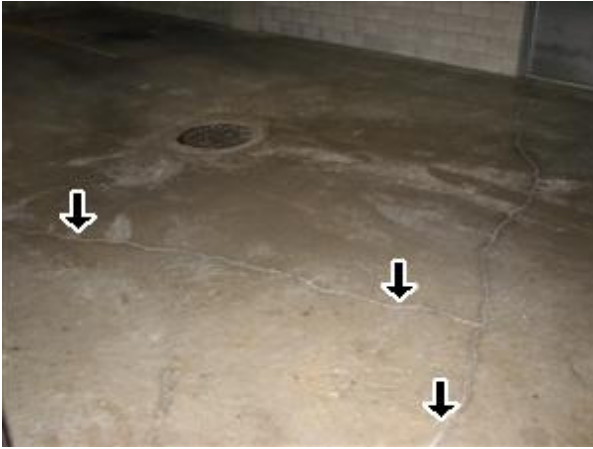
4.2 Picture 1

**4.2** Condition of the floor consistent with the age of the building, and in satisfactory condition with some minor cracking noted. While there are no structural implications, I recommend Strata seal the cracks to prevent any leaking fluids from entering the substrate.

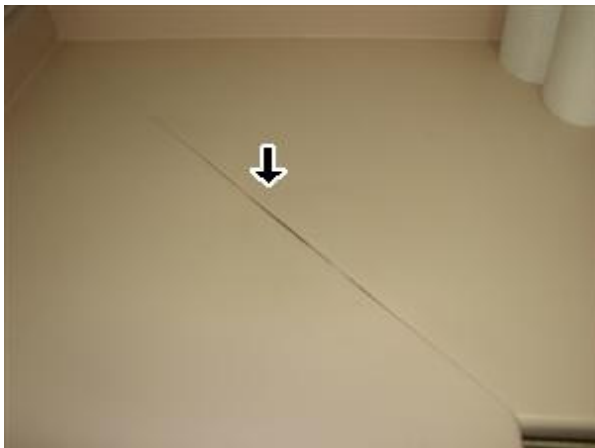
5.2 Picture 1

**5.2** Counter tops were in fair condition, consistent with a kitchen of this age. Some minor lifting at the counter seam was noted. This can sometimes be adjusted from underneath.

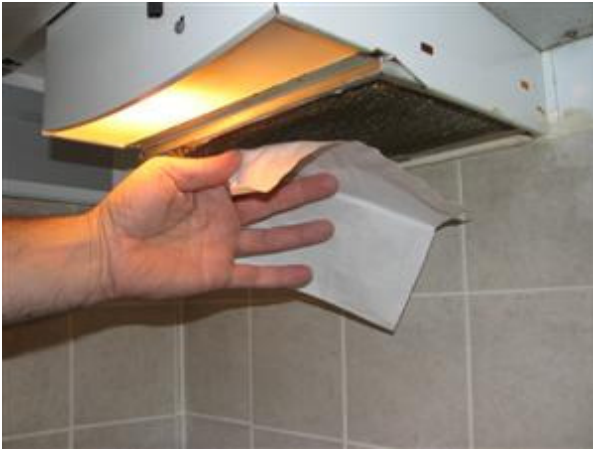
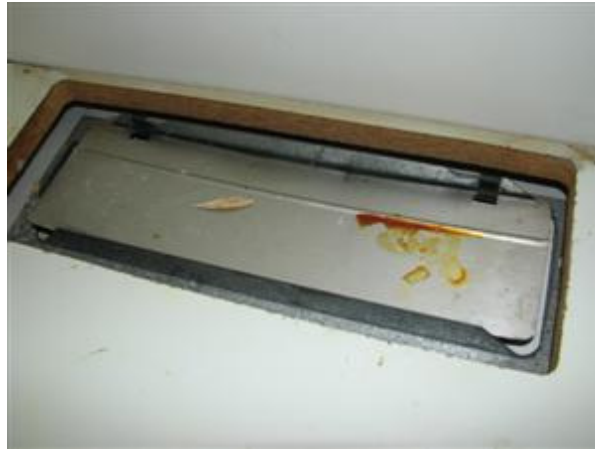
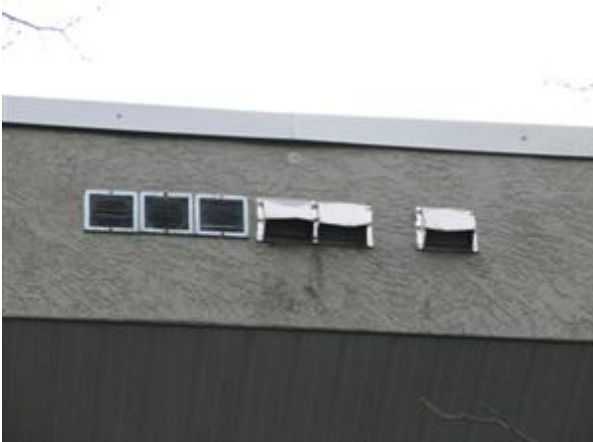
5.5 Picture 1

5.5 There is a vent fan installed, however it is not vented to the exterior (which is ideal), nor does it even recirculate. I recommend venting to the exterior, by a qualified contractor (as you are on the top floor you could likely go straight up through the roof).

It was evident when looking at the building that there was venting to the exterior, so it may be that this vent fan is unique in that it was over-looked and never connected.

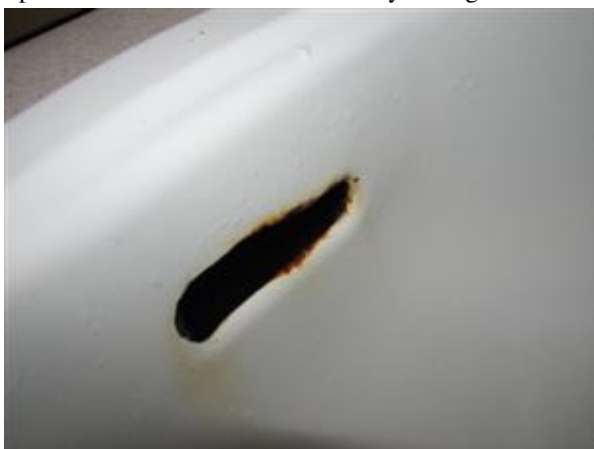
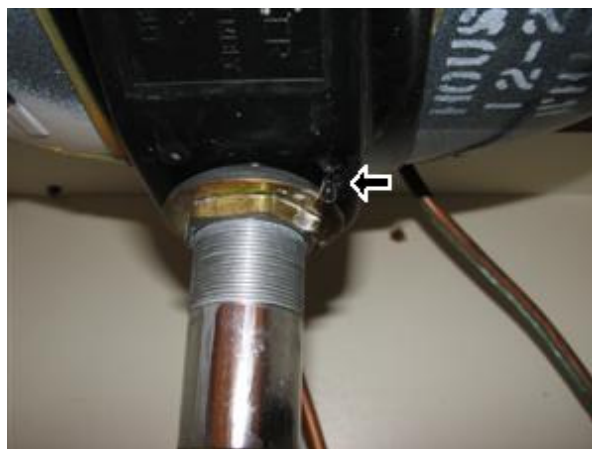
6.0 Picture 1

**6.0** When I test bathroom sinks I fill them to check that the overflow is working. I also check the stopper and draining capabilities then report on my findings. In this instance the overflow leaks. I recommend having a qualified Plumber replace the sink as this will eventually damage the cabinet.

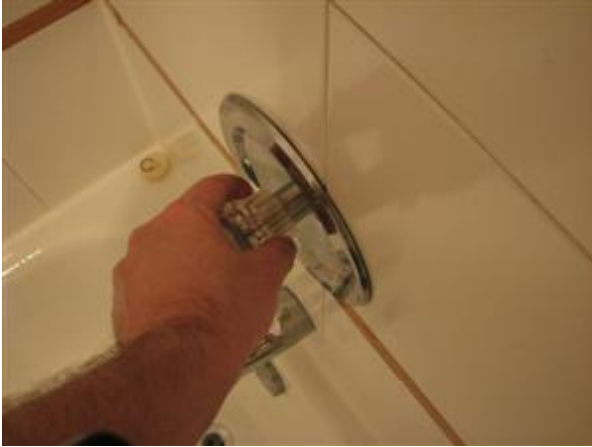
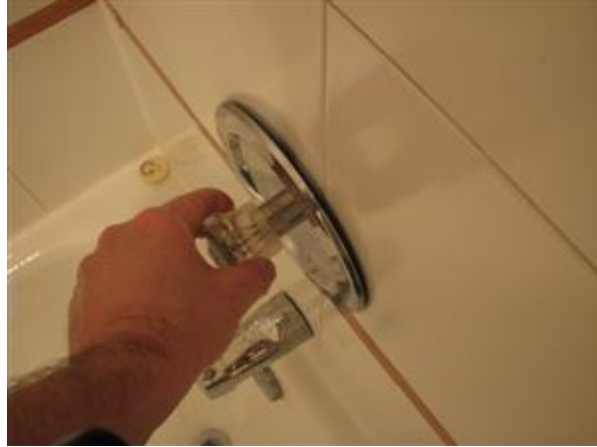
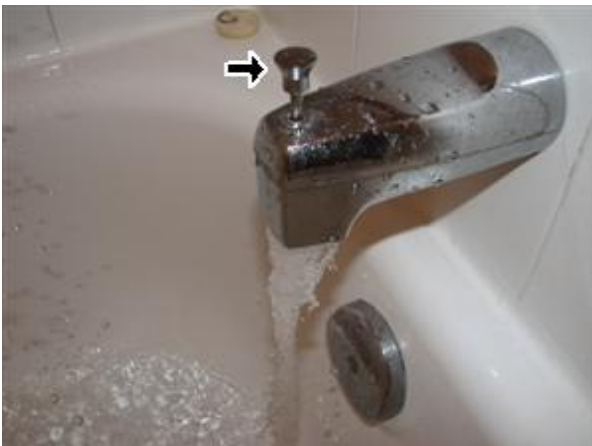
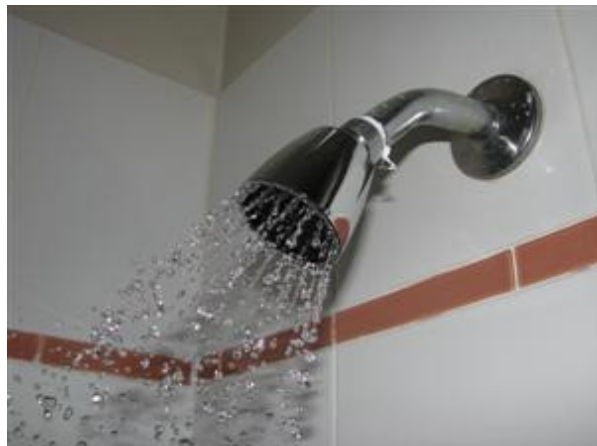
6.3 Picture 1

**6.3** Moisture testing revealed no leaks however the stack (from faucet to shower head) is a little loose in the wall. It was likely never secured well from the get-go. As such, the faucet pulls away from the wall when activated. This "flexion/movement" of the stack can eventually cause an internal wall leak. I recommend this be further evaluated by a qualified Plumber.

Ideally I would like to see the decorative plates caulked with clear silicone to prevent water from getting in behind them. I also recommend you replace the spigot/diverter. Repairing this will give you much more pressure from the shower.

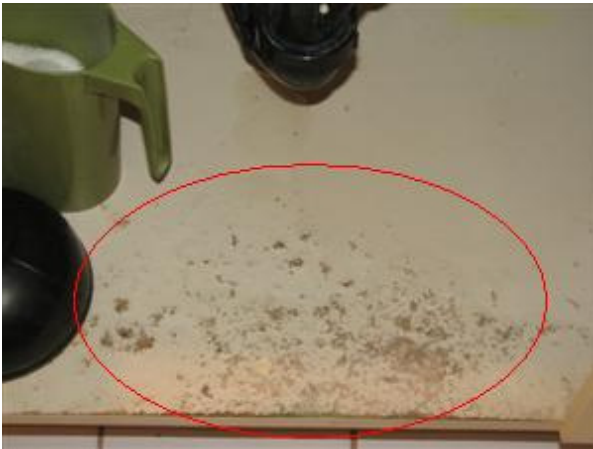
6.5 Picture 1

**6.5** While there has been a little damage from the leaking sink, the cabinetry & counter tops were in satisfactory condition, consistent with the age of the home.

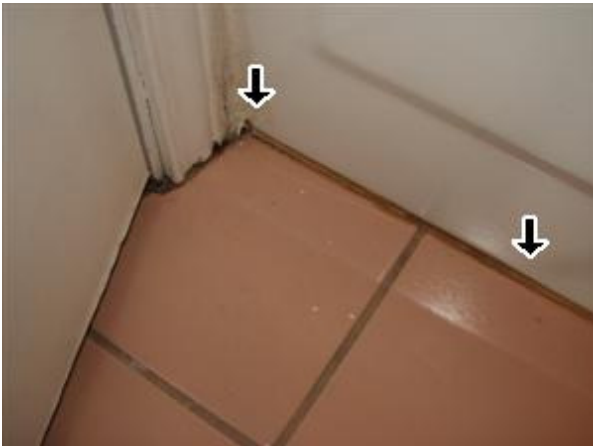
6.6 Picture 1

**6.6** Flooring was tile and in satisfactory condition. I recommend replacing the silicone caulk along floor and tub, as well as cleaning and sealing the grout between the tiles. No deflection noted, however absolute determination of the substrate not possible.

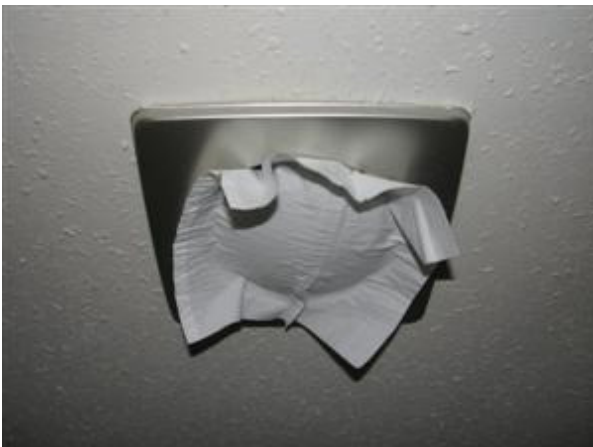
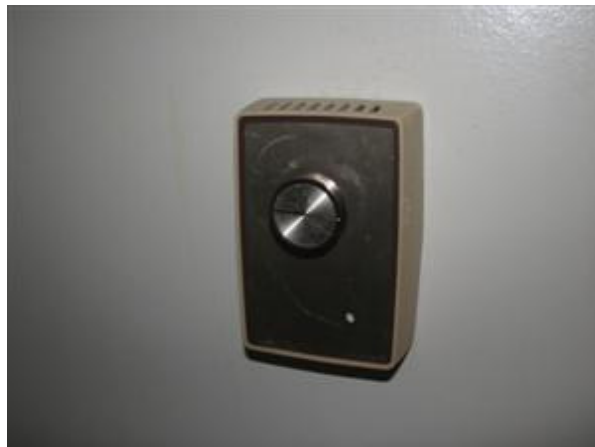
6.10 Picture 1

**6.10** While at best, the light-fan combination was never very efficient, this unit is very noisy, indicative that it is nearing the end of its design-life. I recommend upgrading to a new, higher-CFM quiet fan, and leaving the de-humidistat set at 40% - which will serve to de-humidify the whole apartment.

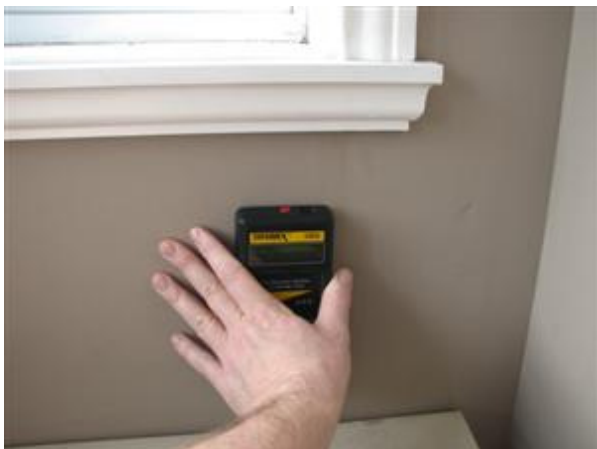
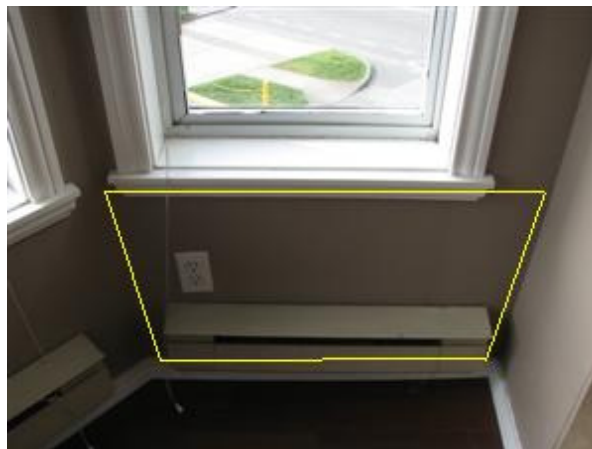
7.1 Picture 1

**7.1** Moisture testing confirmed that the wall under the damaged window is wet (water is actually entering through the window, which does not seal well). I recommend further evaluation by a qualified contractor, who will likely need to remove a 18" x 24" section to confirm the condition of the structure, the absence or presence of mould, and let the wall dry out from the inside.

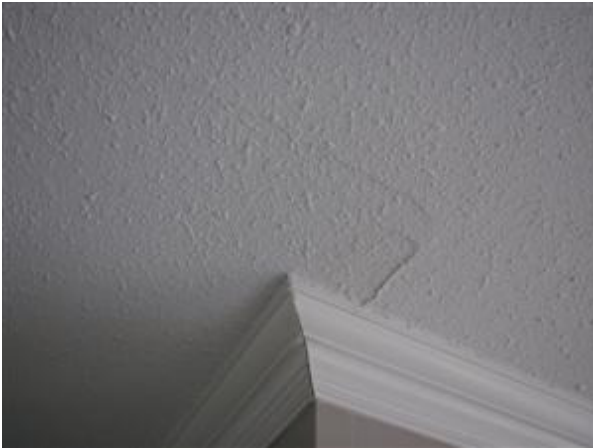
7.2 Picture 1

7.2 Other than some visual evidence of a previous roof leak, creating some minor cosmetic repairs, no issues noted with the ceilings. The homeowner can repair as desired.

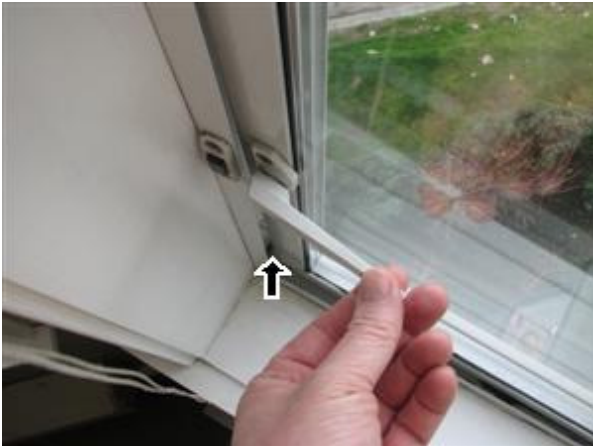
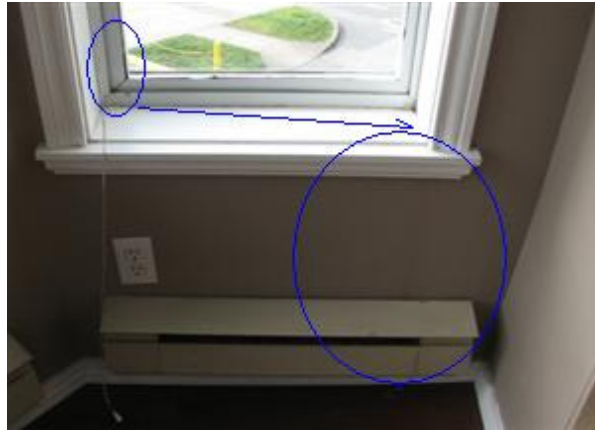
7.4 Picture 1

7.4 While from the exterior no issues were noted with the windows, from the inside it is evident that the Living Room window does not seal as a result of the window being warped. Rain water is entering from the outside, running along the sill, and damaging the wall and floor. I recommend the window be replaced ASAP by a qualified contractor.

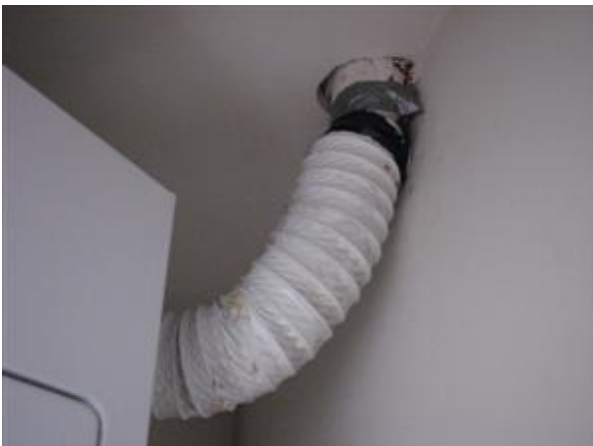
## 7.5 Picture 1

7.5 The Clothes Dryer vent is flexible vinyl. **This material is a potential fire hazard** and I recommend replacing with a solid or flexible metal material.

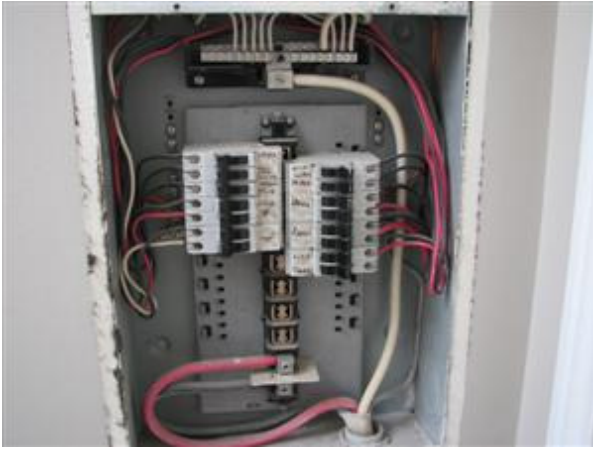
8.2 Picture 1

- 8.0** Underground service not visible. No issues noted.
- 8.1** Ground wire located; no issues noted with grounding from within the panel.
- 8.2** The distribution panel was professionally installed, more than capable of handling the electrical load, with no issues noted.

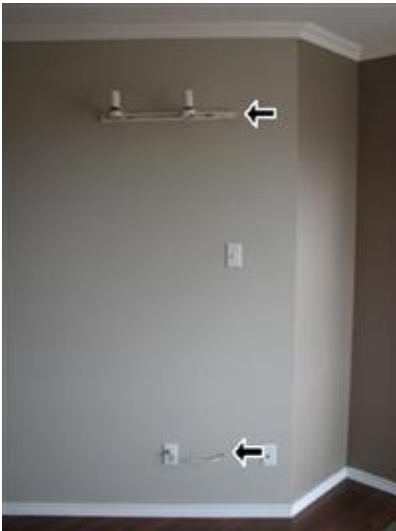
8.4 Picture 1

**8.4** No electrical issues noted with the receptacles, switches or fixtures at the time of inspection. That said, the previous homeowner threaded the electrical cord through the wall. I recommend this be removed.

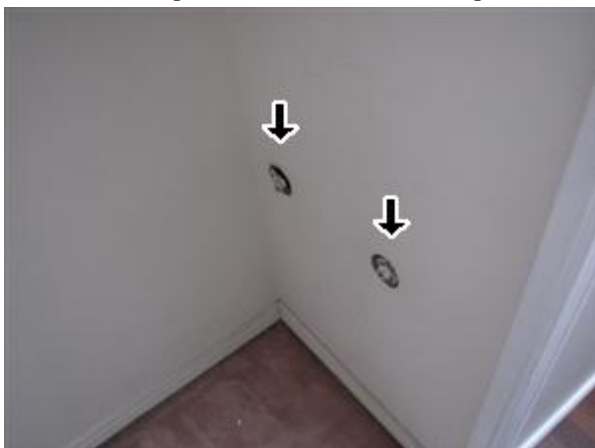
9.0 Picture 1

**9.0** While there are hot & cold shut-off's in the closet for the Tub/Shower, they does not control the rest of the unit. The main shut-off for water is located outside of the suite, which is common for Condos. In case of an emergency, or should you ever decide to replace shut-offs in the home, please ask the Strata for the location or shut-off procedure.

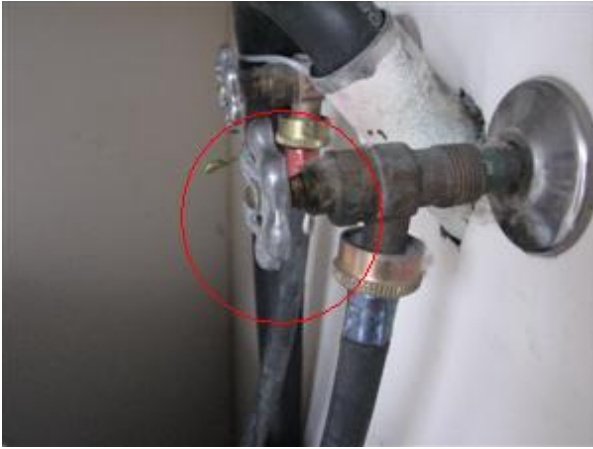
9.3 Picture 1

**9.3** The cold water shut-off behind the Washer leaks when not in its "sweet spot". I recommend these shut-offs be replaced by a qualified Plumber before the slow leak becomes a fast one.

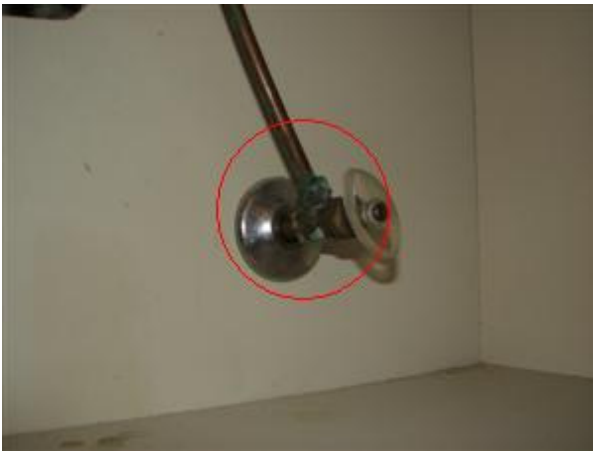
9.3 Picture 2

Looking at the corrosion on the shut-offs under the Bathroom sink, I recommend these be replaced as well.

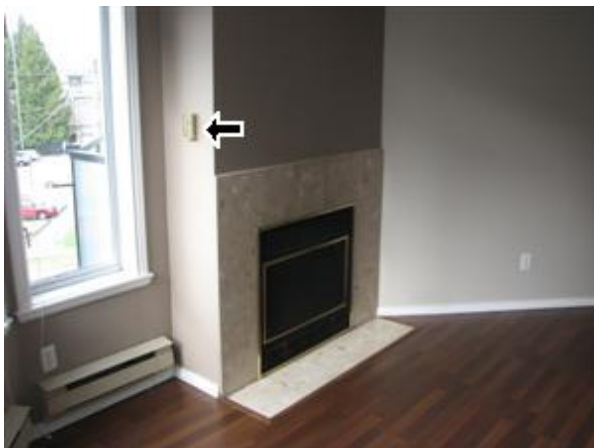
11.1 Picture 1

**11.1** No issues noted with the gas fireplace itself, which was operable at the time of the inspection. The FAIR rating is due to the thermostat. Ideally, the thermostat should have been located away from the window and direct sunlight (on the other wall, a few feet away from the fireplace). Its current location does not allow the thermostat to accurately read the room temperature during the day. Because the sun was shining at the time of the inspection, while it was actually 20 degrees in the room, the fireplace thermostat "thought" it was 25+ and would only activate when set at maximum. I recommend the thermostat be relocated.
