# Inspection Report

**West Coast Home Inspections**

## General Summary

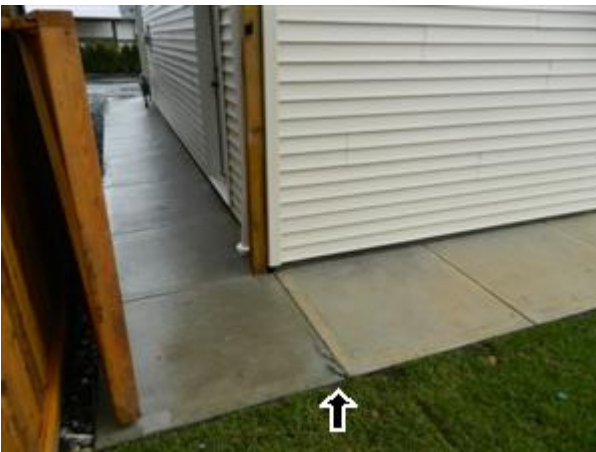
1.1 Picture 1

The concrete sidewalk is chipped at the back of the home. As the home is brand new I would request that it be repaired.

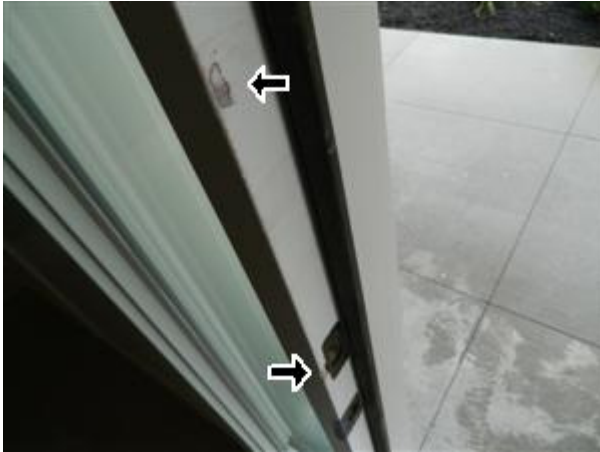
2.1 Picture 1

The front door has taken a beating during construction. The frame itself is scarred and split...

Again, as this is brand new construction, I recommend the door and frame be replaced by the builder.

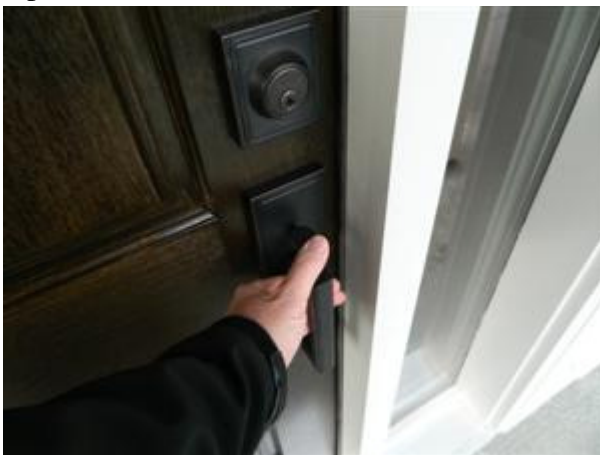
2.1 Picture 3

... the door handle is difficult to open unless you tug the door towards you at the same time as you depress the thumb lever...

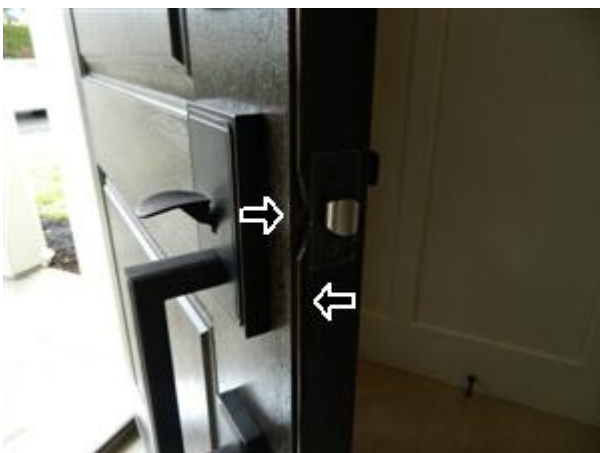
## 2.1 Picture 4

... and as a result of being forced, the door has split & chipped.

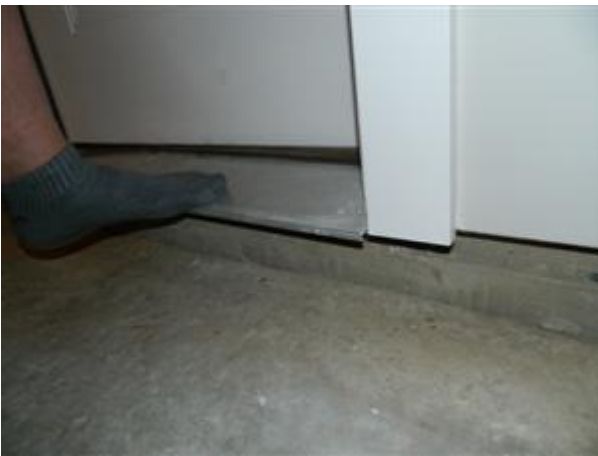
4.5 Picture 1

The width of the concrete footing is too narrow for the sill/threshold. There is excessive flex when you step on it and in time it will break down. I recommend the Builder widen the concrete footing at the door opening.

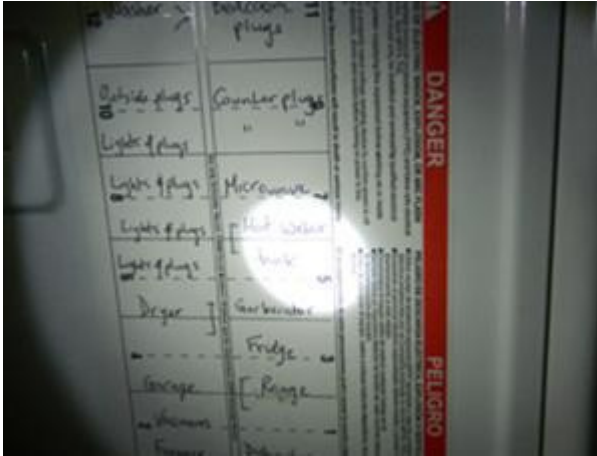
6.2 Picture 1

It would appear that the Electrician didn't pull the Hot Water Heater wire into the panel. It is

labeled on the panel (Picture 1), and the 30 AMP Breaker has been installed (Picture 2)...

The Builder will need to call the Electrician back to correct this.

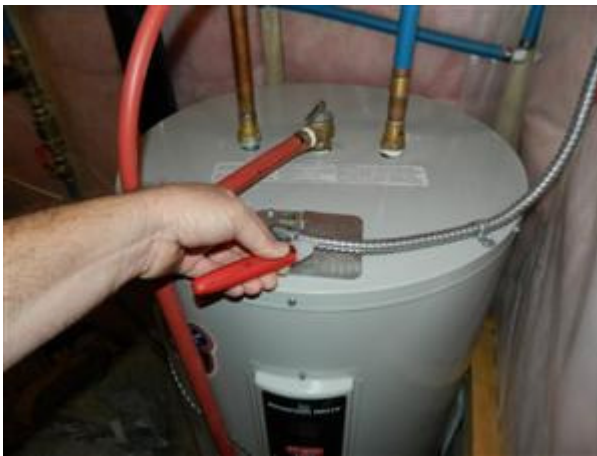
6.2 Picture 3

... but there is no power at the "business end", as the wires are missing in the panel.

Ironically, this escaped the Electrician's notice, the Builder's notice, the Hot Water Tank installer's notice, and the City Building Inspector's notice.

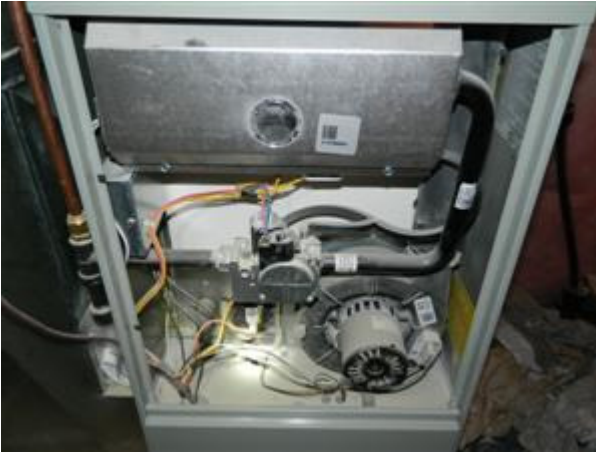
9.0 Picture 1

The new high-efficiency gas furnace is in proper working order. To maintain it in good condition I recommend service checks by a licenced HVAC Tech, approximately every two years.

*\* There is a lot of "construction dust" in the furnace. I recommend having it professionally cleaned prior to occupancy.*

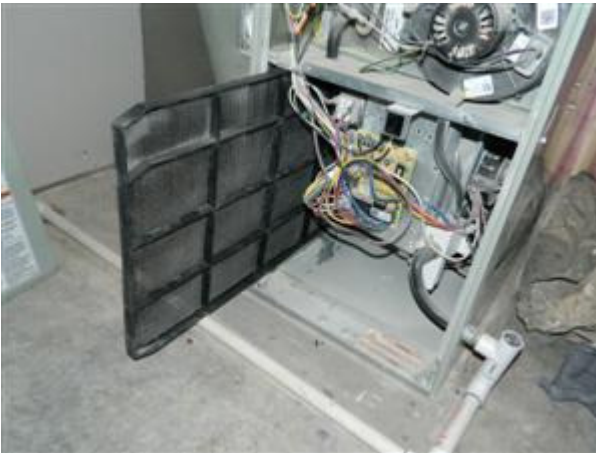
9.7 Picture 1

This type of filter is FAIR (at best), and is currently packed with dust. It is little more than a screen which filters out only the larger particulates. A disposable paper filter would be much more efficient.

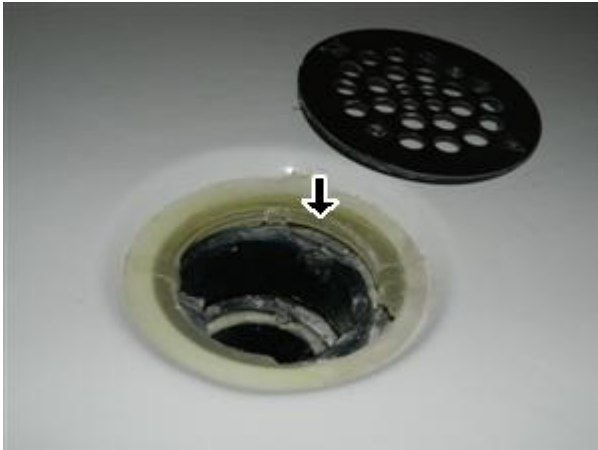
10.4 Picture 1

The shower drain has been damaged and the installer attempted to use silicone to hold the grate in place. You can not due this as the shower will very likely leak into the floor unless properly repaired.

For the life of me I can not see how this could have occurred AFTER the shower pan was installed - meaning that it was most likely damaged prior to the installation of the shower and the installer put it in anyway.

Do not use this shower until the Builder has a Plumber repair this.
